Fatality Investigation Report

OR 2008-01-1

Mechanic killed by excavator bucket during maintenance

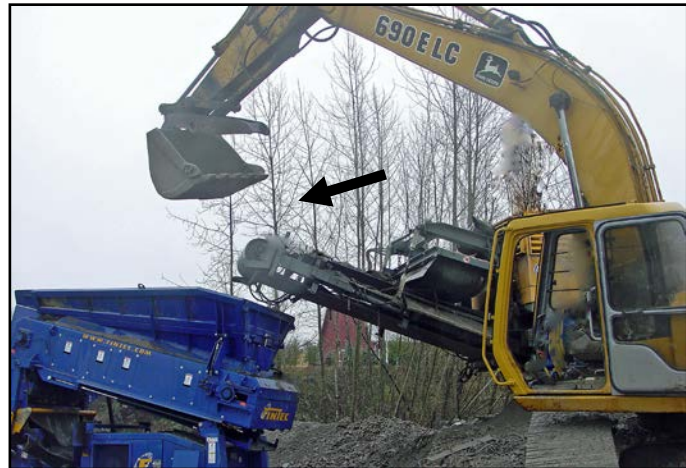
A mechanic was standing on the conveyor of a rock crusher (arrow), rigging the frame to an excavator bucket to lift the conveyor for maintenance. The excavator boom unexpectedly swung and dropped, and crushed him.

The rock crusher was shut down completely. It is not known whether or not the crusher was locked and tagged out. The hydraulic excavator was placed so the boom and bucket were positioned above the rock crusher's off-load conveyor ramp. The mechanic climbed onto the 4-foot wide conveyor and stood on the end about 15 feet from the ground to rig the connection. He wore no fall-protection equipment. The victim could not reach the lifting eye on the boom with the chain, so the excavator operator entered the cab and turned on the engine to reposition the bucket. The mechanic remained at the end of the conveyor. The operator of the rock crusher remained at the controls of his machine, waiting to start up for the lift. After positioning the bucket, the excavator operator leaned out of the right cab window to get a better look toward the mechanic. The operator was wearing a rain jacket, and as he sat back down into his seat, the jacket caught on the top of the left-hand lever control for the boom arm, and activated the boom. The boom dropped and swung to the right, and the bucket struck the mechanic and crushed his head against the conveyor frame.

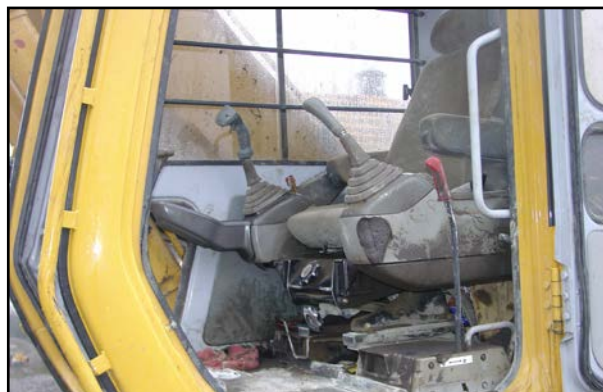
After leaning out of the right side cab window for a better view of the mechanic who was working near the bucket, the operator sat back down into his seat and his rain coat caught on the left-side control handle for the boom, causing the boom to swing and drop.

Recommendation #1: Loose clothing should be avoided when operating machinery and all tools/equipment should be stored outside the cab.

- Do not operate equipment with loose clothing, a tool belt, or other items that could interfere with the operator controls. In some machines the engine may not need to be running for an operating control to result in machine movement. Several Oregon occupational fatalities in the past decade were caused by unintentional activation of a control in the cab, including a caught jacket pocket similar to this incident, a tool belt, and a heavy object thrown onto an unguarded foot pedal (Readers are referred to Investigation Report #s OR 2003-15-1, OR 2004-07-1, and OR 2007-17-1).
