### **3.** EXISTING FACILITY CONDITIONS

The focus of this chapter is on the Marquam Hill Campus where most of OHSU's buildings are located. The process of building condition assessment is discussed, and each building is rated to enable assessment of its future uses. In addition to the physical condition of a building, its historical significance and its location also play a part in deciding upon its future. Definitions of twenty-year facilities needs in the next chapter are used in conjunction with this assessment of building conditions to suggest logical scenarios for the use, adaptation or replacement of each building.

# Facilities Condition Assessment

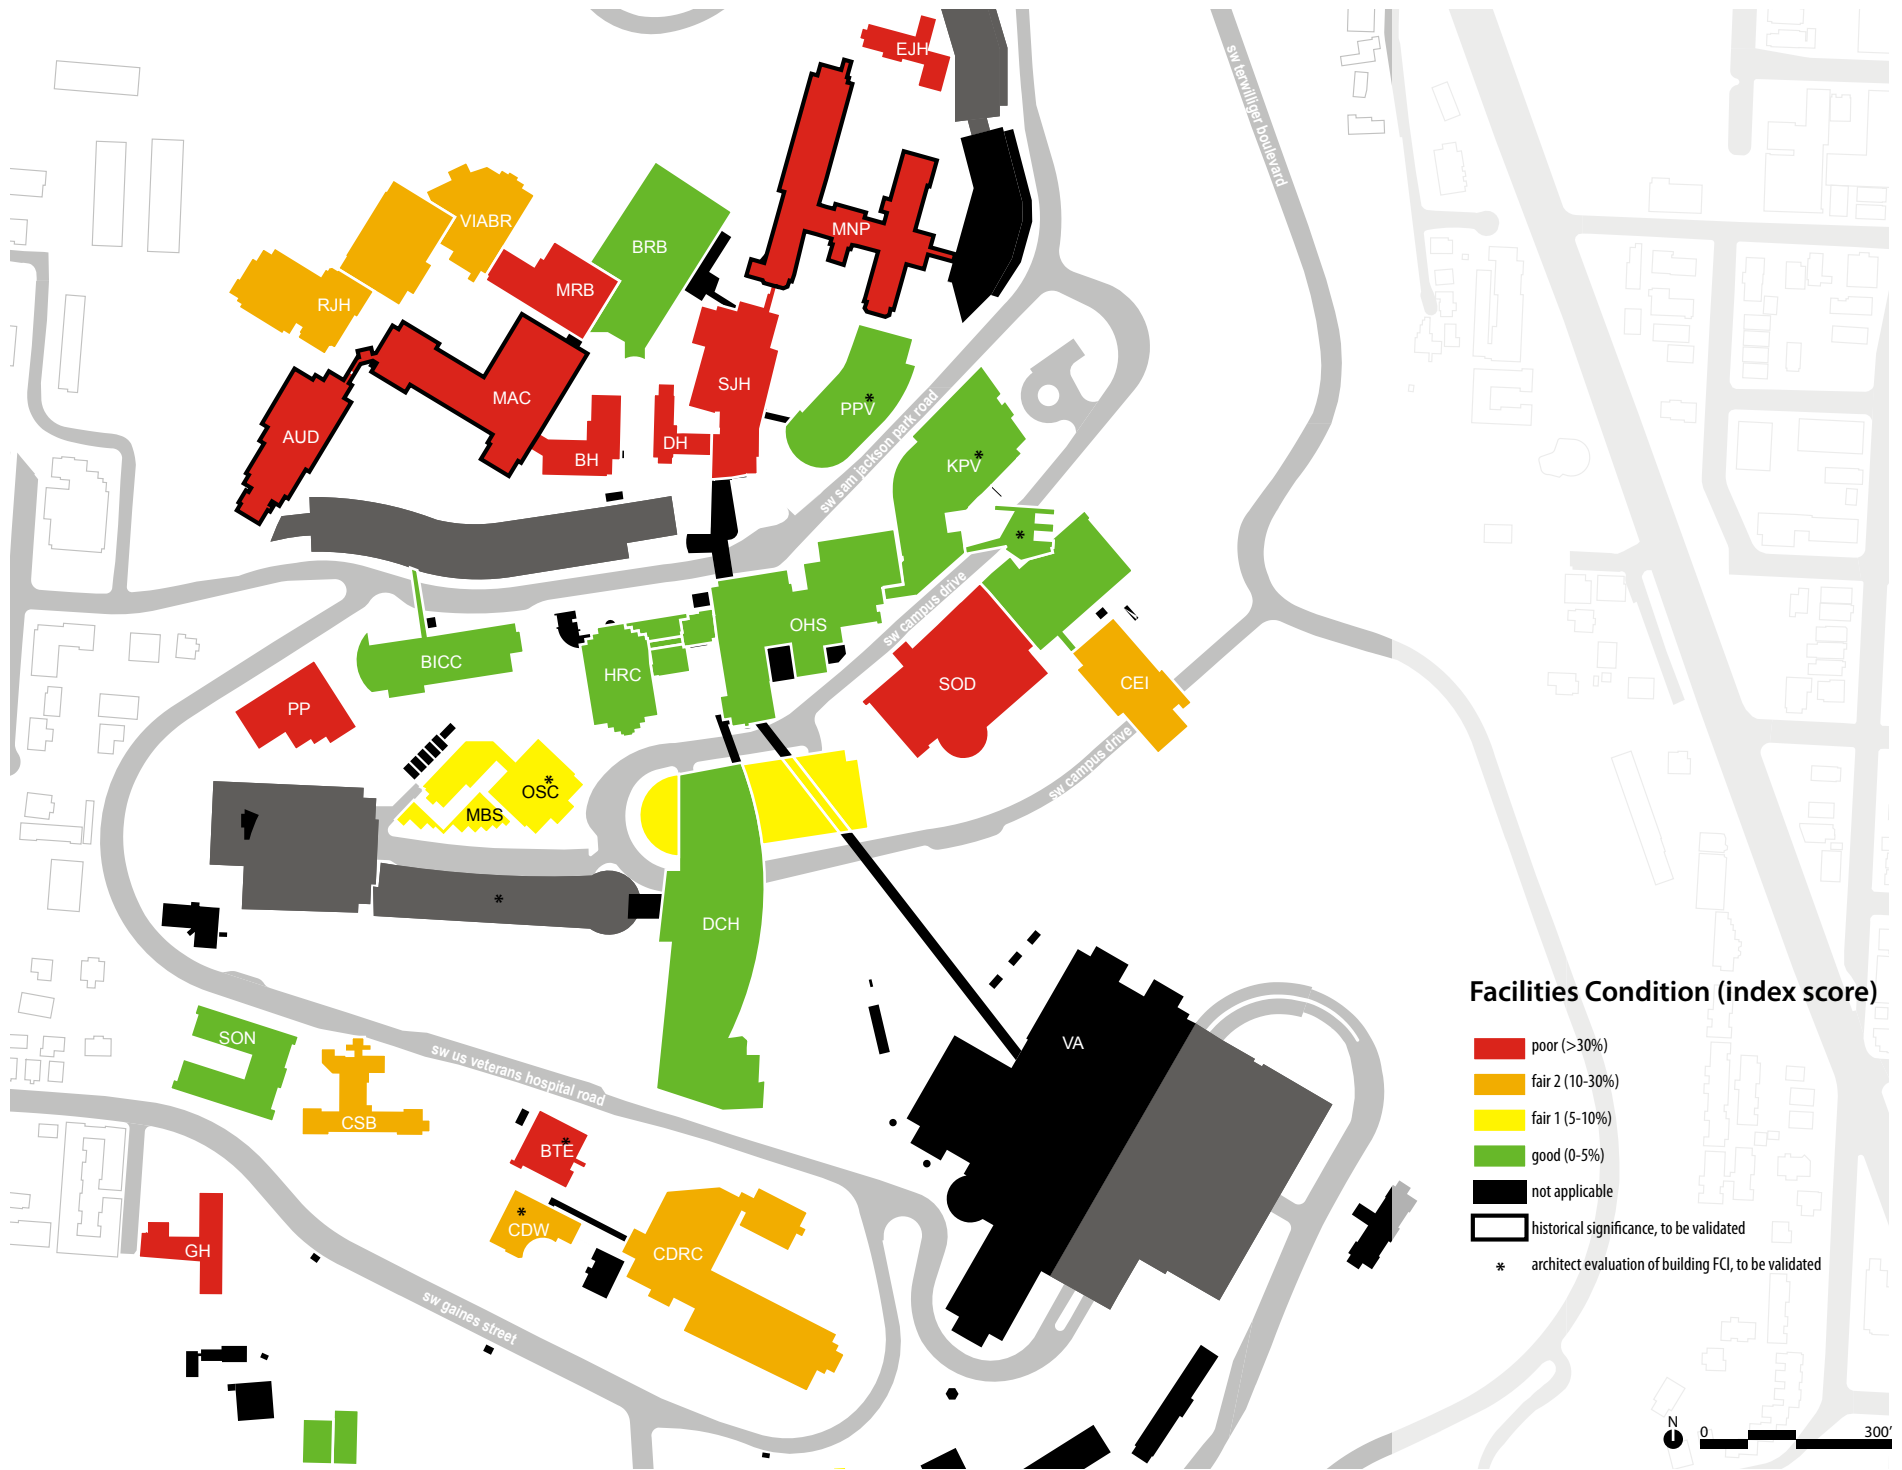
### Facilities Condition Index

This scoring was based on the total value of necessary maintenance yet to be implemented, and includes mechanical, electrical, and structural improvements related to the physical operation of the building. The building inventory was classified under the categories shown on the "Facilities Condition" plan.

Outstanding maintenance as a percentage of building value.

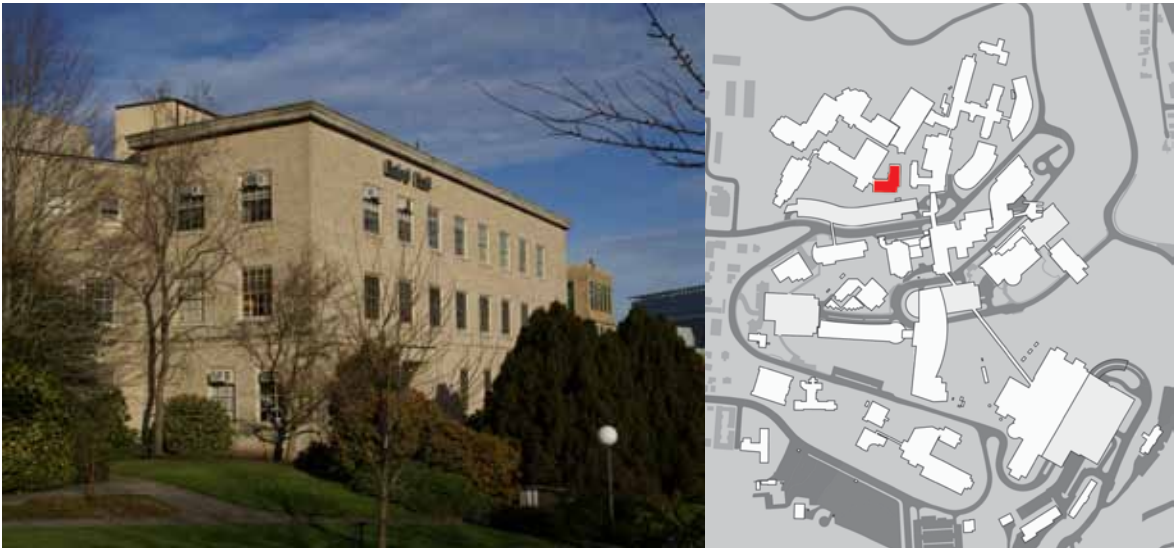
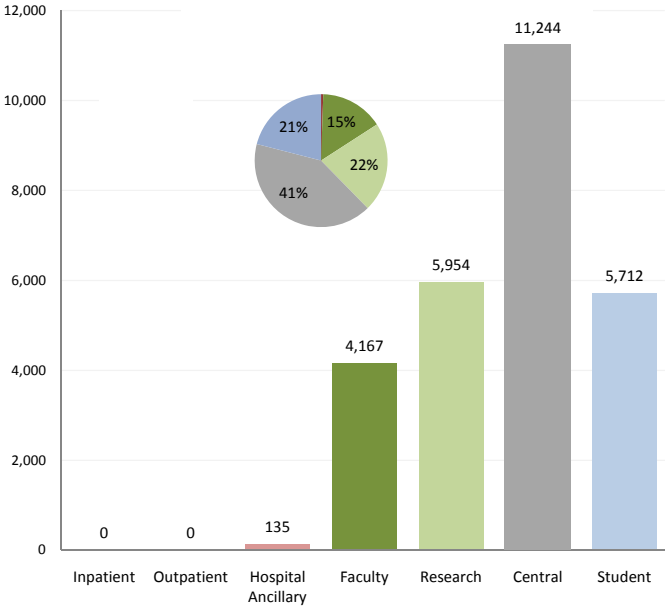
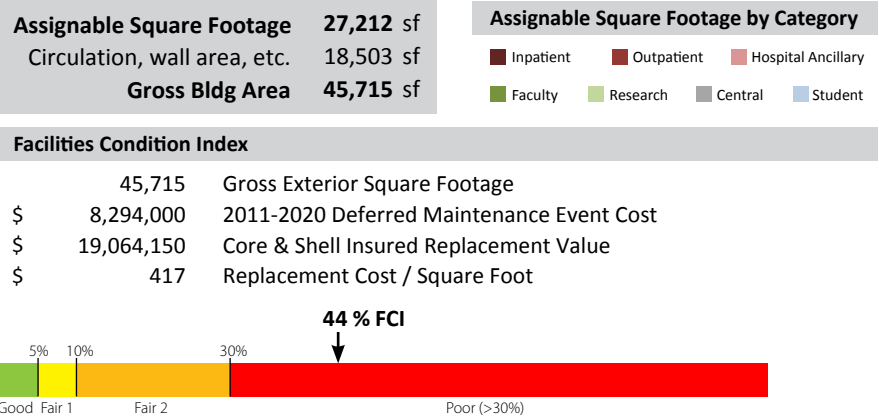
# Baird Hall (BH)

Originally constructed in 1949, Baird Hall contains approximately 45,715 GSF on four floors. It was built to house the University’s Administration and it continues to include the Office of the President and senior executive leadership. Other than Administration, the main uses are: Dermatology, Obstetrics & Gynecology, Perinatology, and Student Services/Affairs.

Overall condition of the facility indicates normal wear for a building of its age. With a FCI rating of 44%, Baird Hall has the fourth worst rating of university buildings. Given its age and condition. Baird Hall will need extensive renovation if it is not replaced.

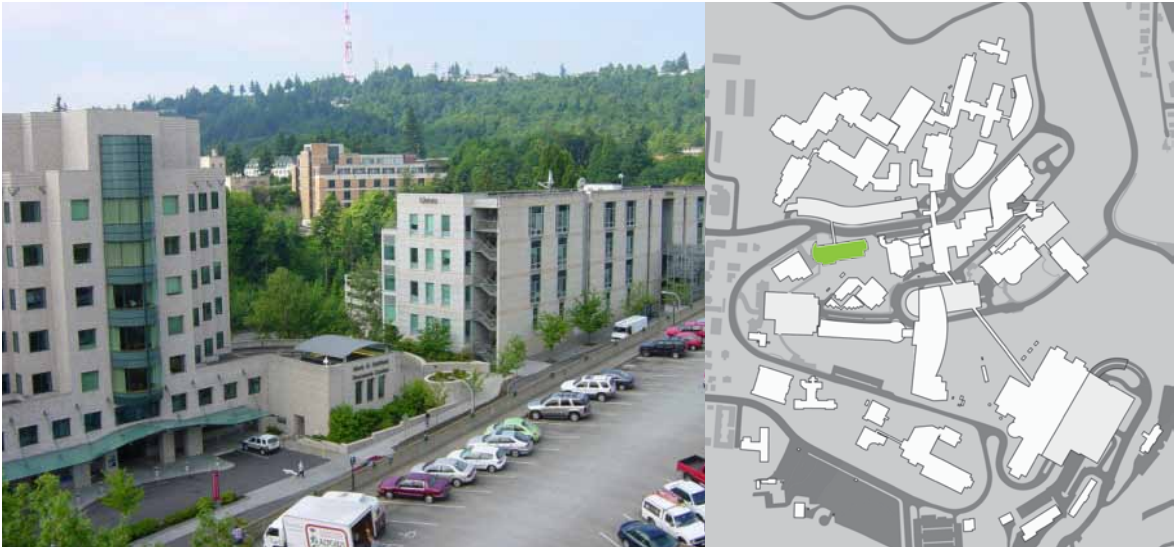
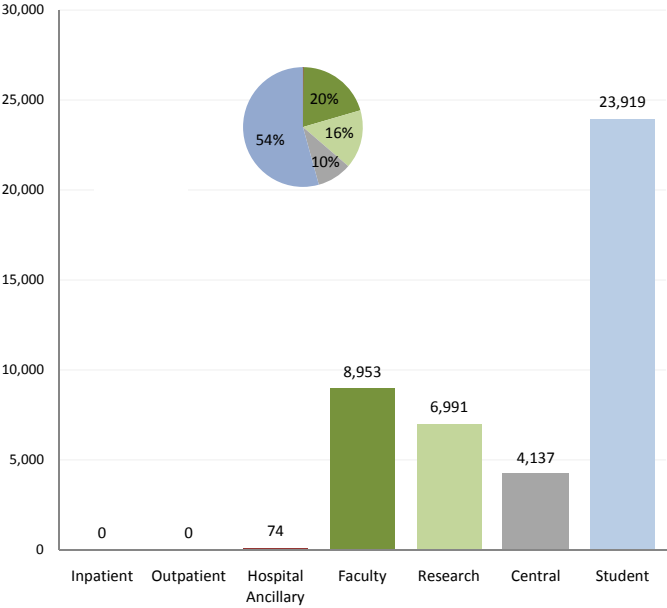
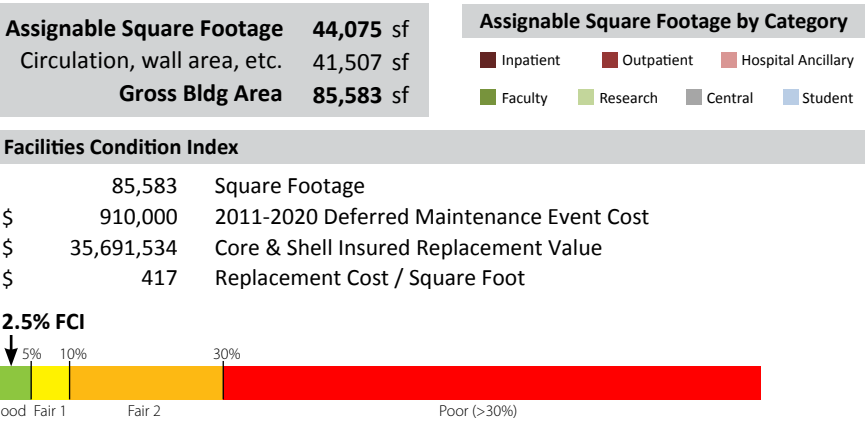
# Biomedical Information and Communications Center (BICC)

Built in 1991, this facility contains 85,583 GSF on six floors. Serving as the main campus library, BICC accommodates: Medical Informatics, Educational Communications, Information Technology Group and the Library Services for students, faculty and staff. Overall condition of the facility is rated 'Good' with a FCI rating of 2.5% reflecting some wear and tear.

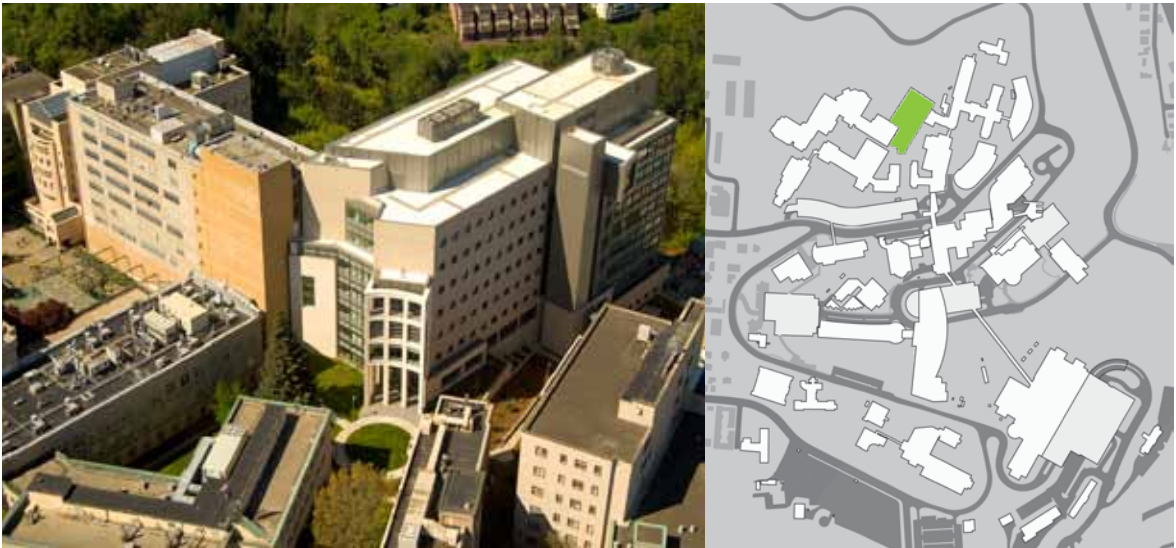
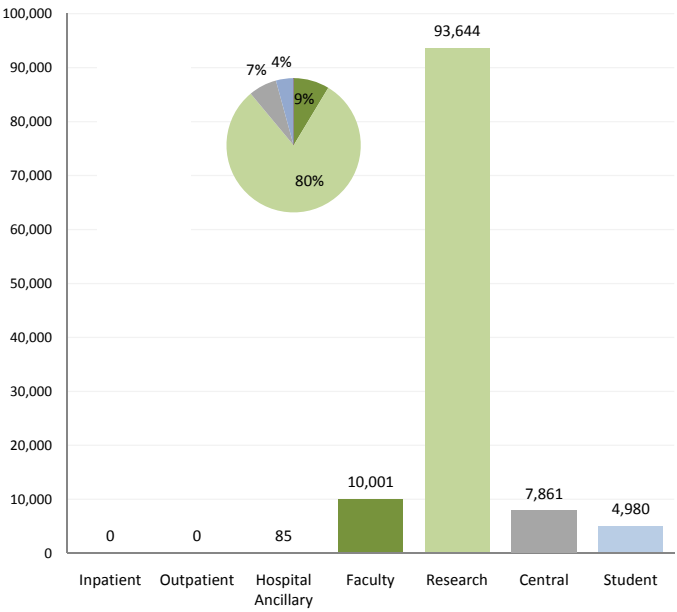
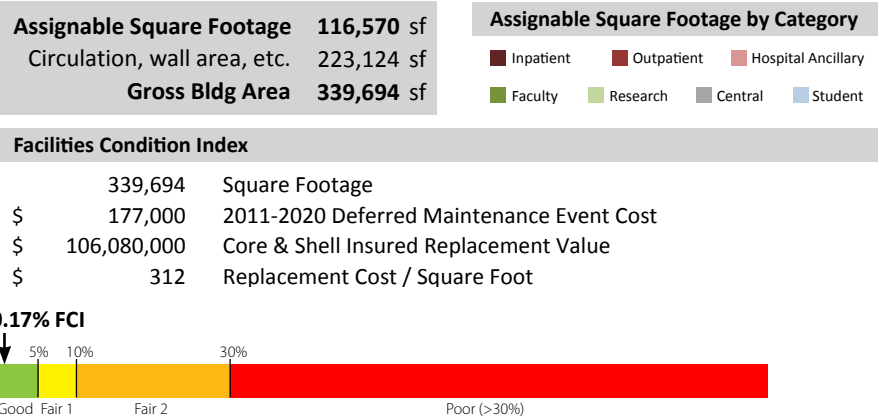
# Biomedical Research Building (BRB)

Built in 2005, the Biomedical Research Building contains 339,694 GSF of total area over 7 usable floors. The building consists of over 162,000 sf of Research/laboratory space and an Advanced Imaging Research Center that is 16,000 sf. A few of the multidisciplinary teams of scientists and clinicians that work together in this building are from Knight Cancer Institute, Comparative Medicine, Pediatric and Neurology departments.

With a FCI rating of .17%, this LEED certified research facility is in excellent condition.

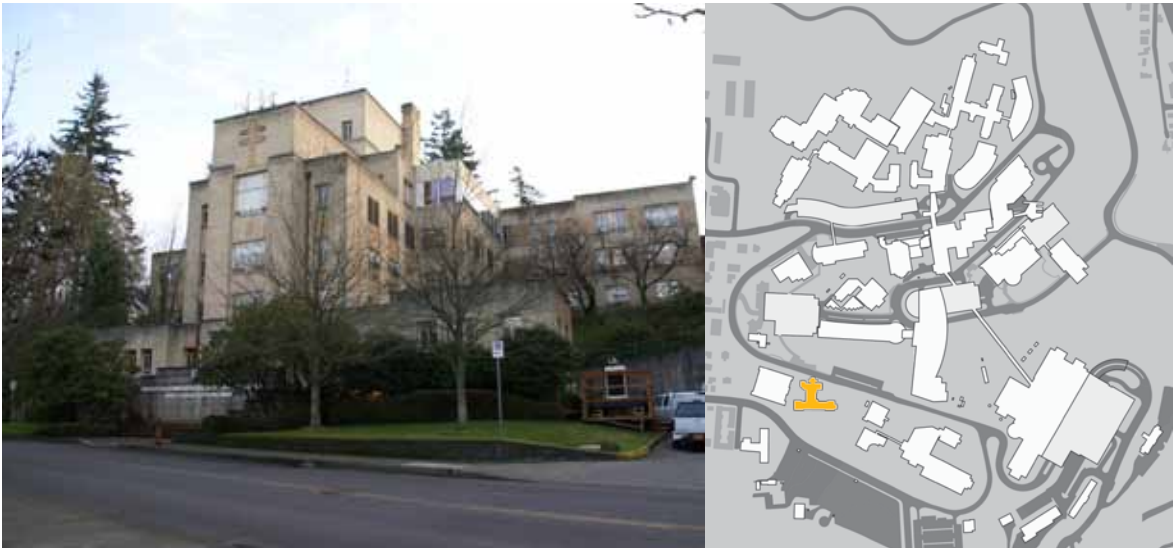
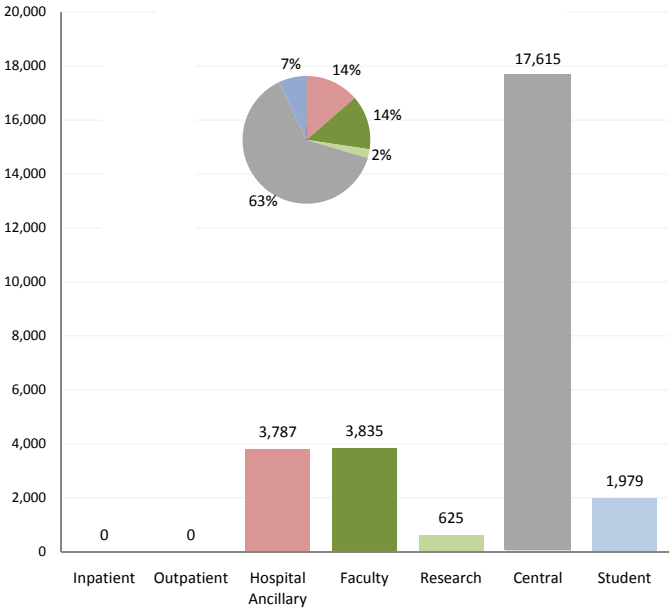
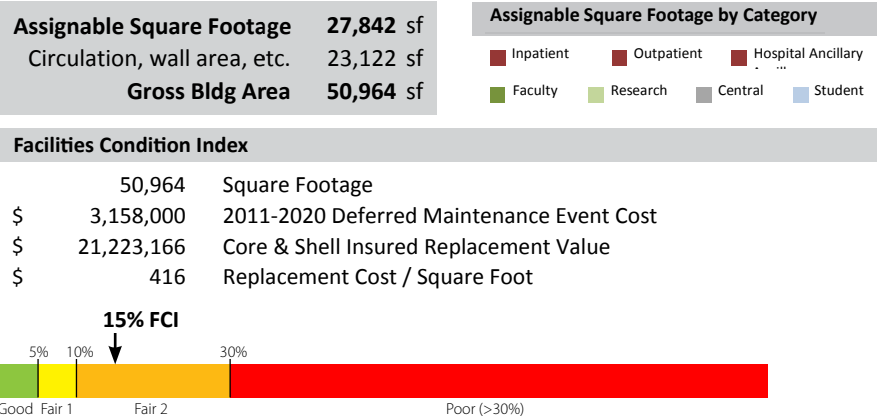
# Campus Services Building (CSB)

Built in 1939 as an isolated hospital for tuberculosis patients, this facility contains 50,964 GSF on seven floors. This building houses central service functions of Design & Construction as well as the Public Health & Preventative Medicine Department and ITG. With a FCI rating of 15%, the building is considered to be in ‘Fair’ condition, but given its age, it could be demolished and its programs backfilled into other buildings.

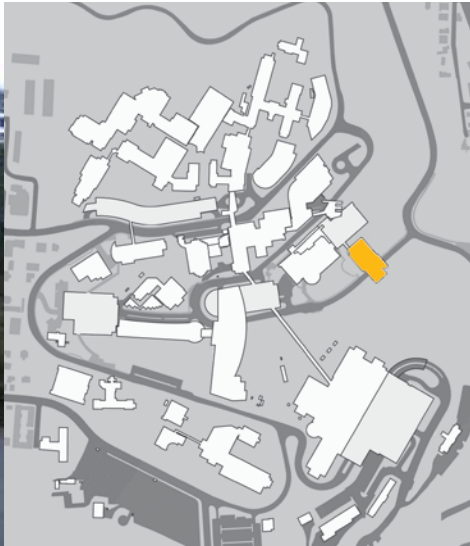
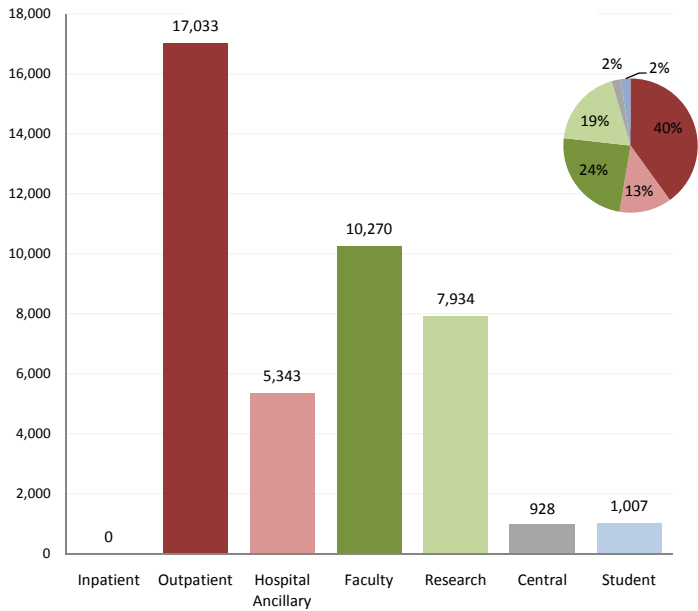
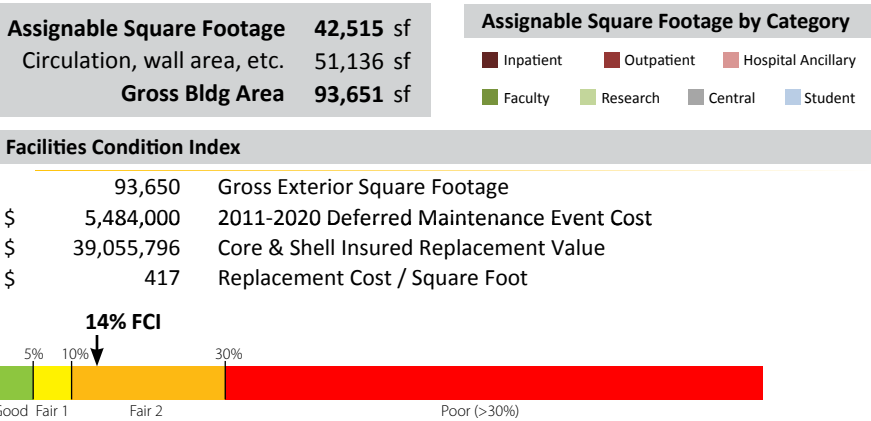
# Casey Eye Institute (CEI)

Built in 1991, Casey Eye Institute contains 93,650 GSF on six floors and serves as the gateway to the Marquam Hill Campus from Terwilliger Blvd. CEI is a world-recognized academic regional eye center that attracts top specialists from around the globe. CEI primarily houses Ophthalmological Research, adult and pediatric eye clinics. Review of the facility indicates that this building is in fair condition with a rating of 14%

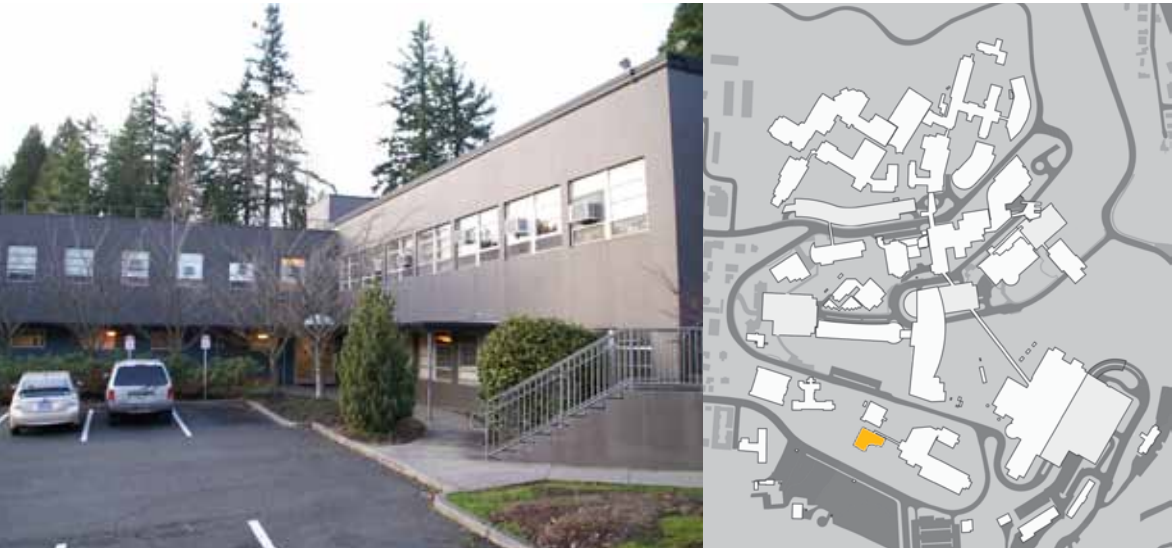
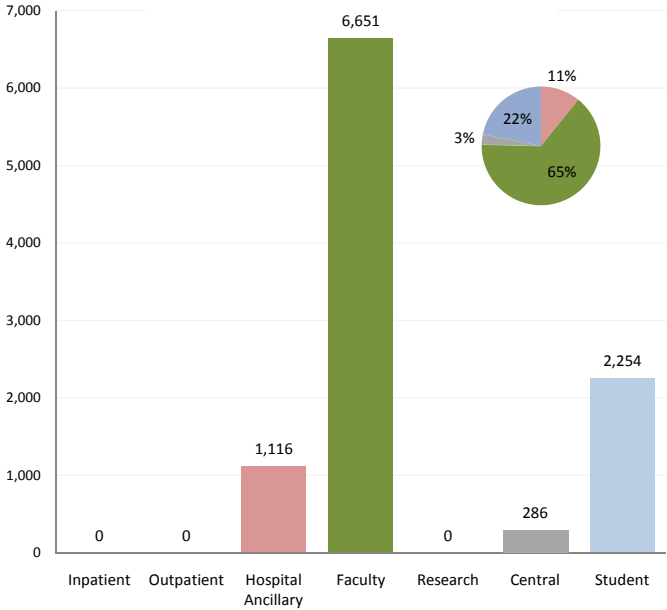
# Child Development and Rehabilitation Center West (CDW)

Built in 1954, Child Development & Rehabilitation Center West contains 15,801 GSF on two floors. Faculty offices for the Emergency Medicine department occupy most of this space. Review of the facility indicates this building will remain useful with moderate maintenance and repairs.

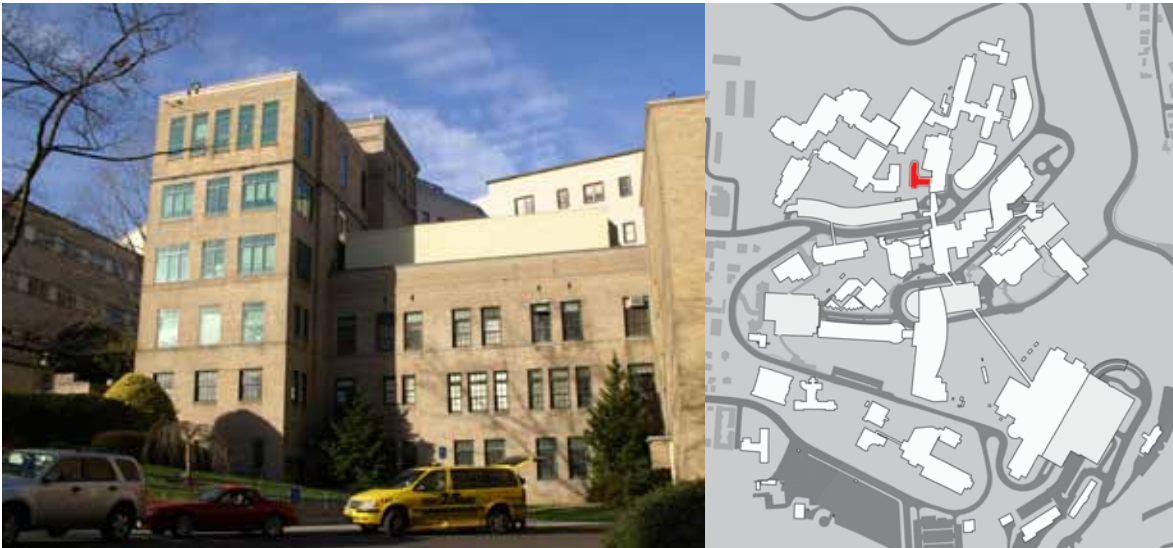
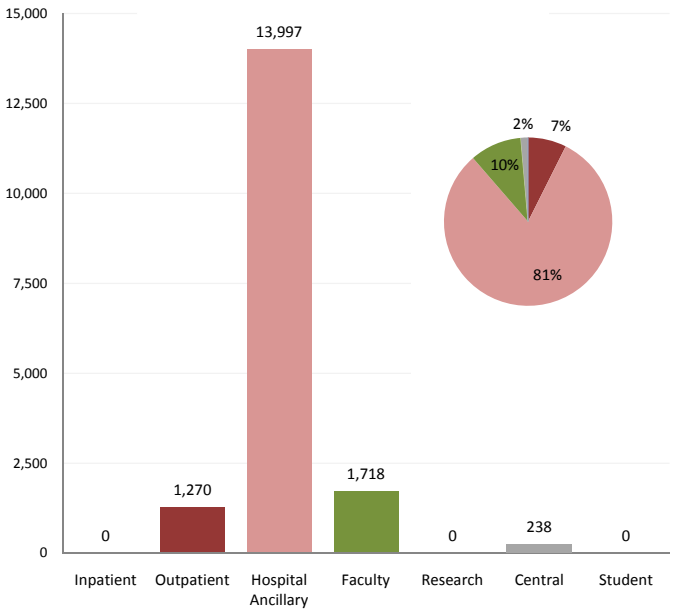
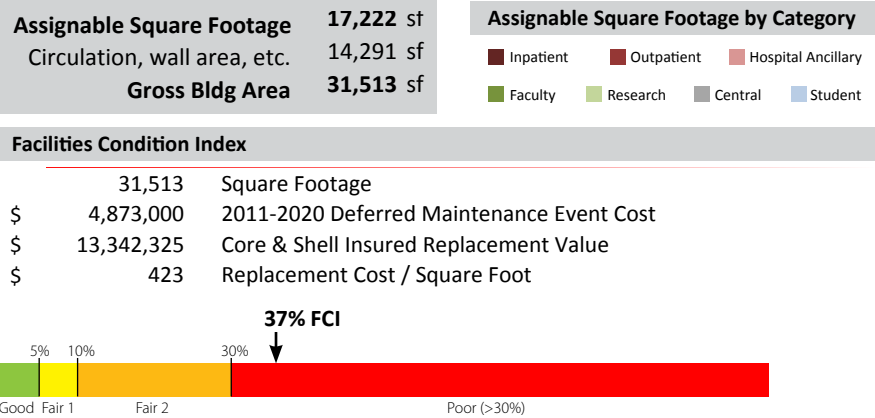
# Dillehunt Hall (DH)

Built in 1924 as the original Doernbecher Children’s Hospital, Dillehunt Hall contains 31,513 GSF on six floors. Dillehunt houses clinical laboratories and associated administrative offices. With a FCI rating of nearly 37%, Dillehunt Hall is considered to be in ‘Poor’ condition and is a candidate for demolition.

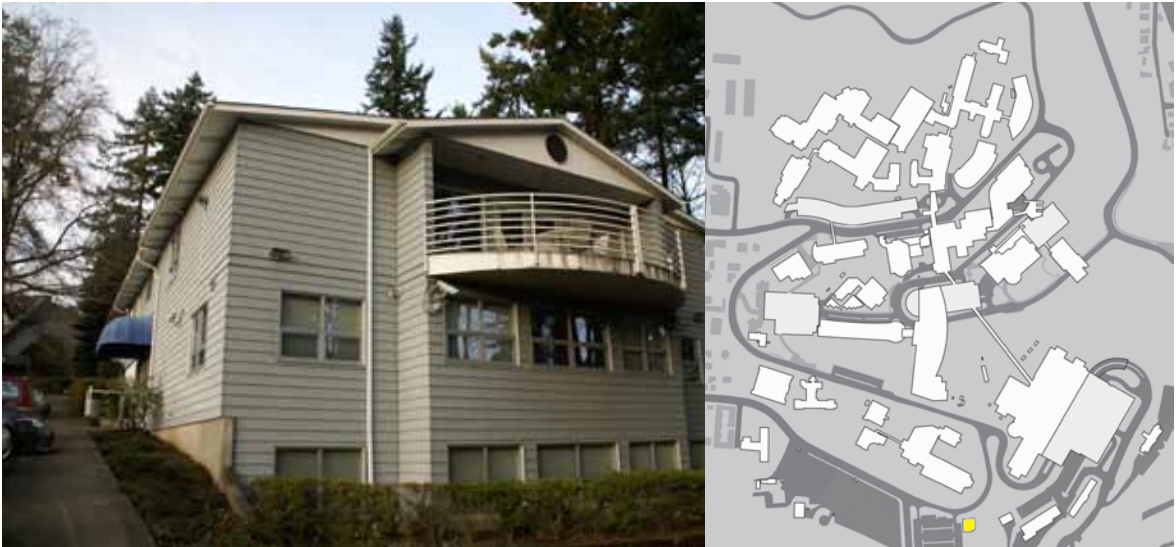
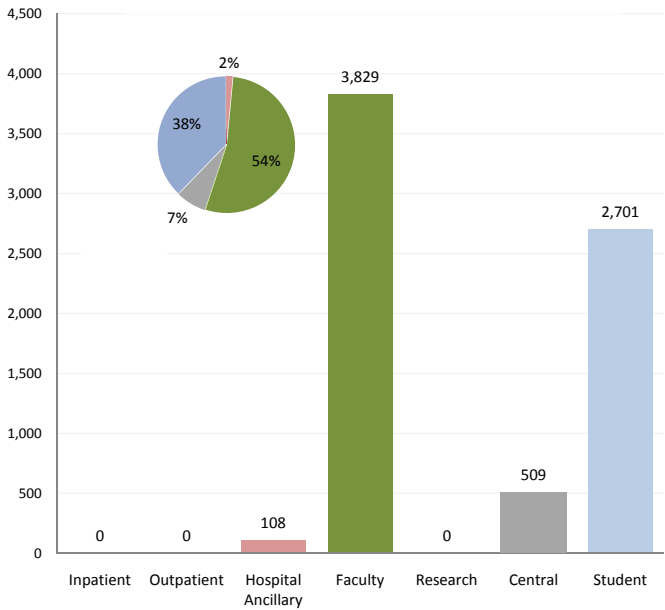
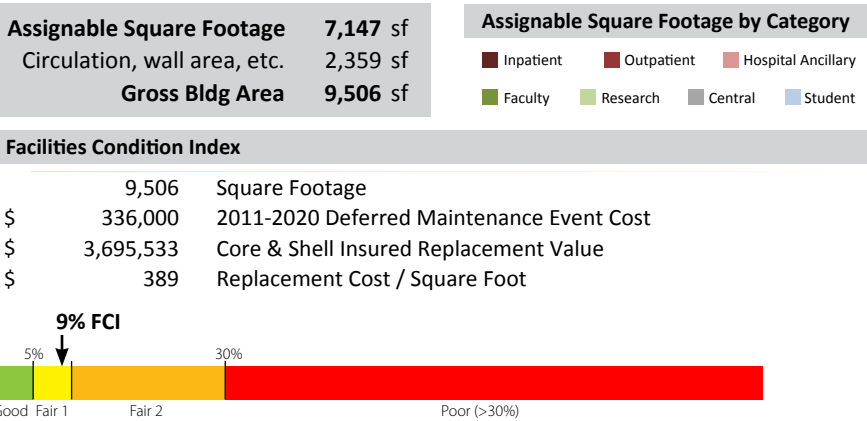
# **Dotter Interventional Institute (DOT)**

Established in 1990 when the University purchased and renovated a former fire station, Dotter Institute contains 9,506 GSF on two floors. This small building comprises Faculty Offices and a few Laboratories for the study of Interventional Therapy. Dotter has a FCI rating of approximately 9% and is considered to be in 'Fair' condition.

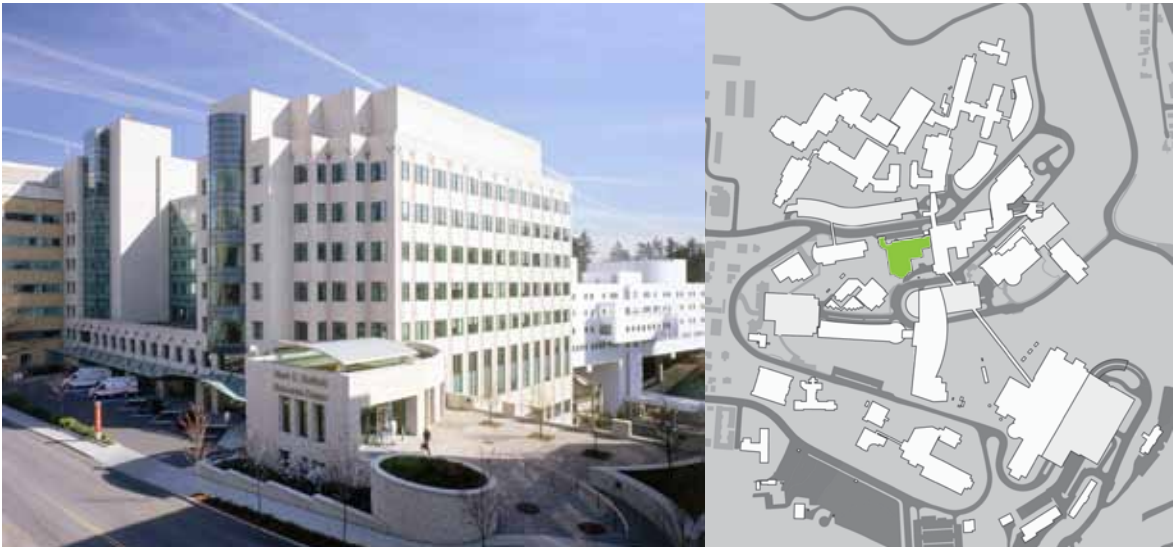
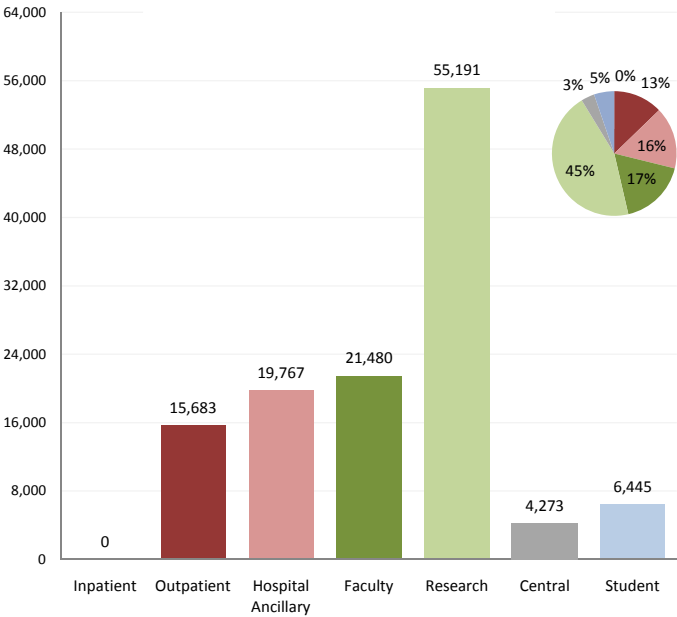
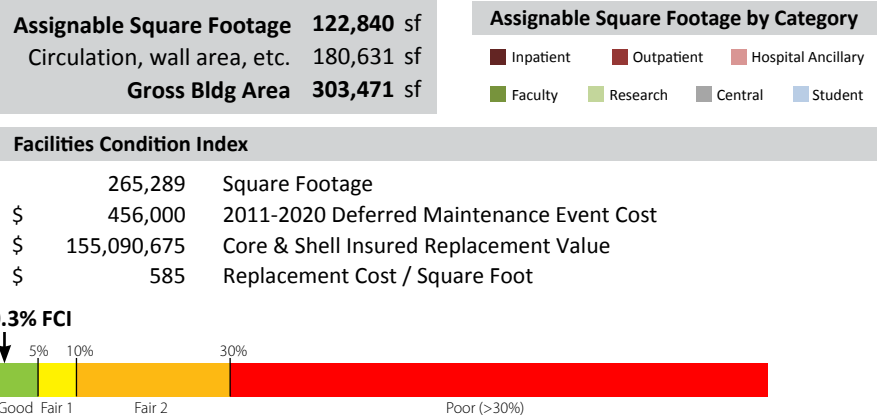
# Hatfield Research Building (HRC)

Built in 1997, Hatfield Research Center contains 303,471 GSF on 12 floors. HRC houses the Emergency Department and offices for a variety of departments including Knight Cancer Institute, the Department of Neurology, and the Jungers Center for Neurosciences Research. HRC has the best FCI rating (less than 1%) of hospital buildings and is in ‘Good’ condition.

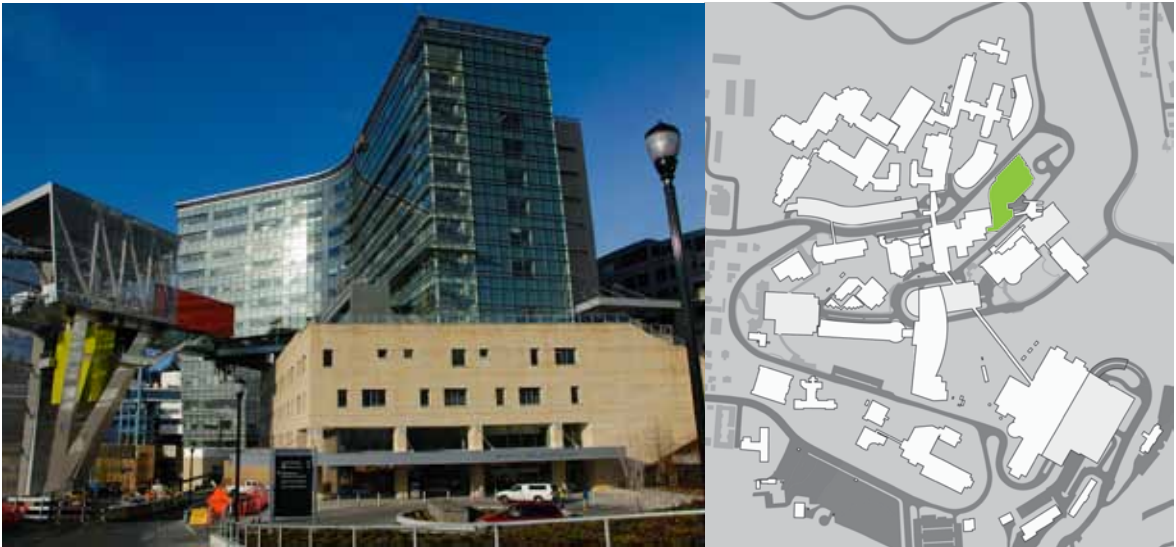
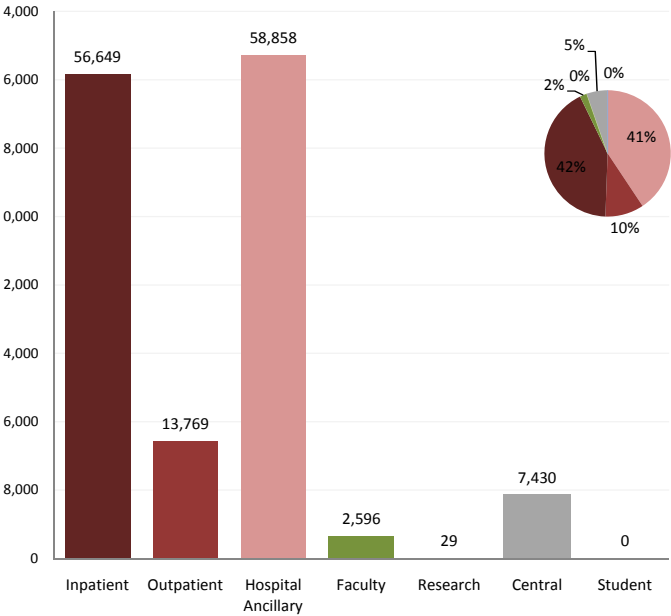
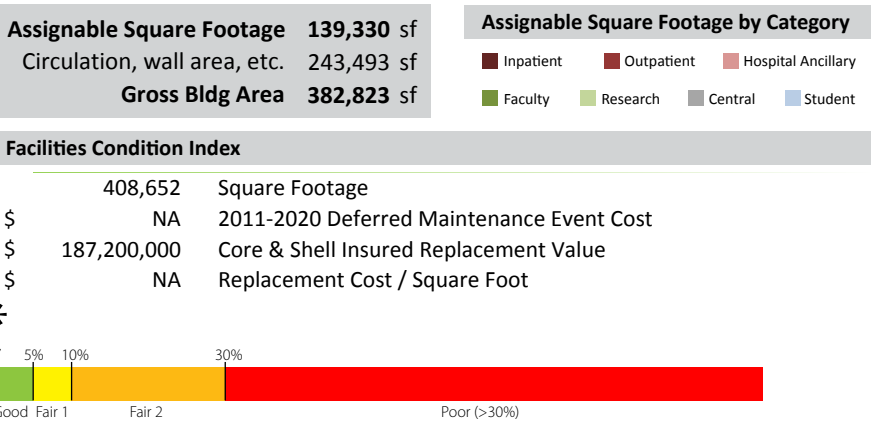
# Kohler Pavilion (KPV)

Built in 2005, Kohler Pavilion contains 382,823 GSF on 13 floors. KPV houses inpatient and outpatient facilities for a variety of departments including Neurology/ENT, Oncology, and Cardiac Care. No FCI rating is available for this building but given its age, it is considered to be in very good condition.

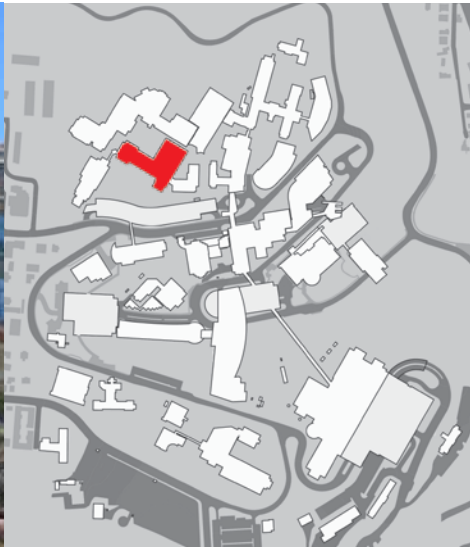
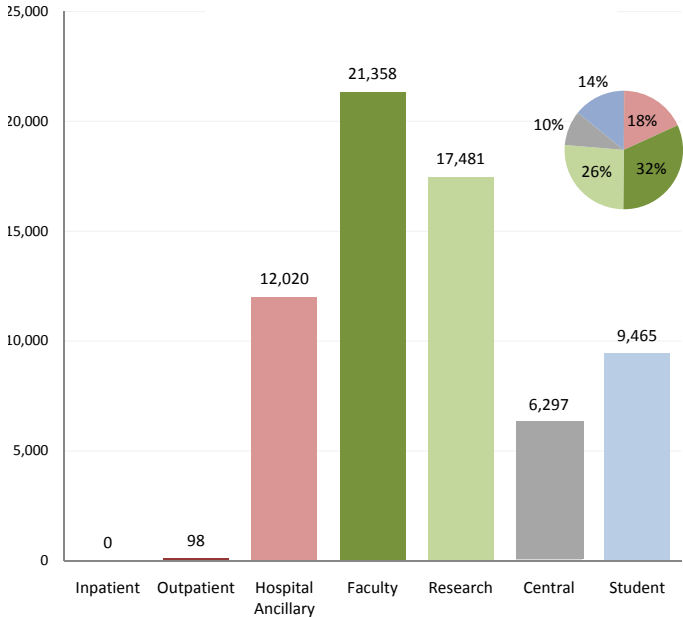
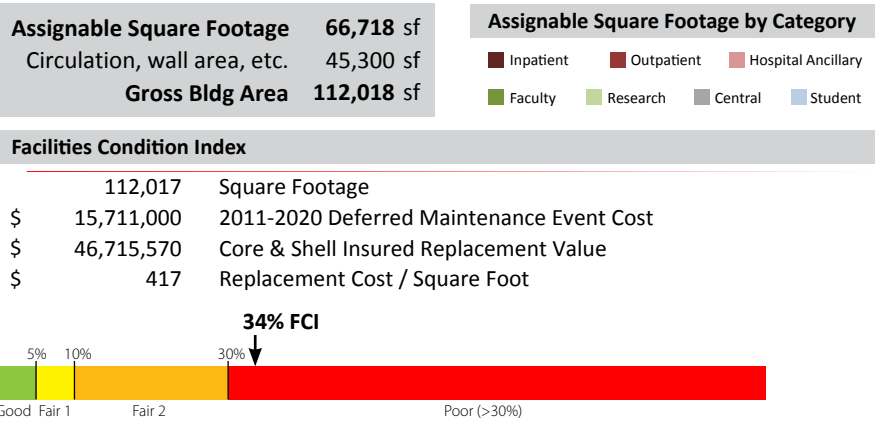
# Mackenzie Hall (MAC)

Built in 1919, Mackenzie Hall contains 112,018 GSF on five floors. MAC primarily houses the School of Medicine Dean's Office, Research Development Administration, classrooms, laboratories, and faculty offices for a variety of departments including Surgery, Neurology, Molecular and Medical Genetics. MAC has a FCI rating of 34% and is considered to be in 'Poor' condition. Moderate to extensive renovation will be needed in the future. Given Mackenzie Hall's historic significance, it is doubtful that it would be demolished.

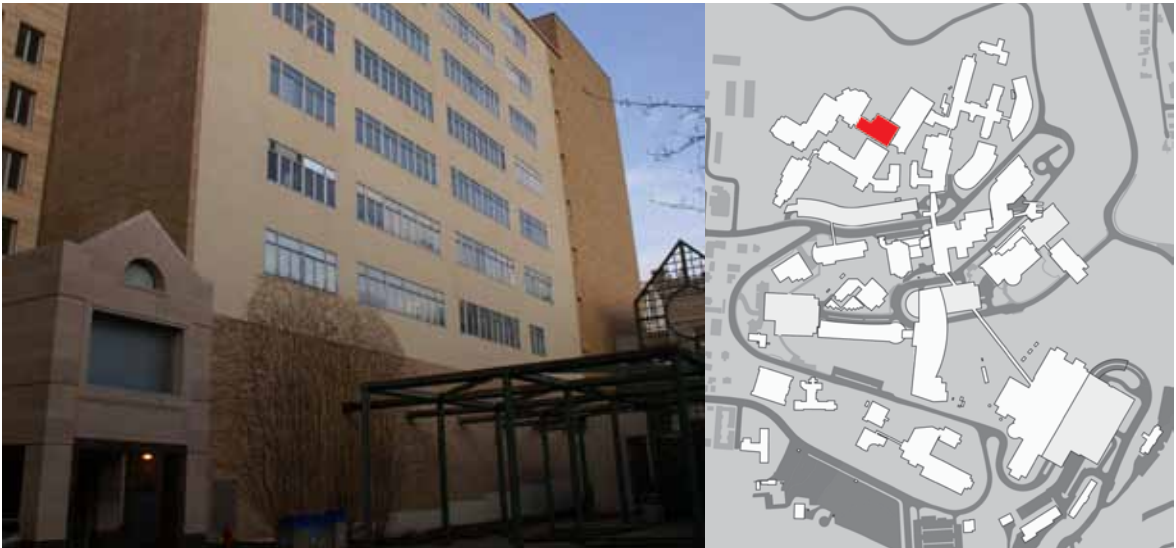
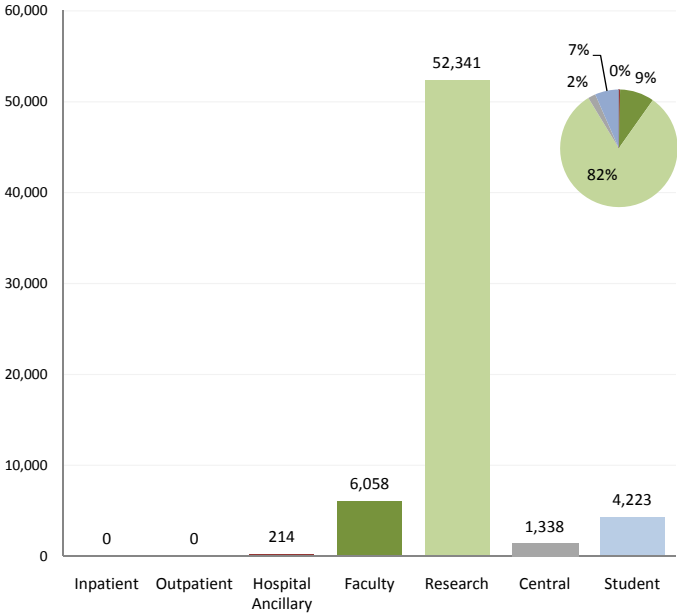
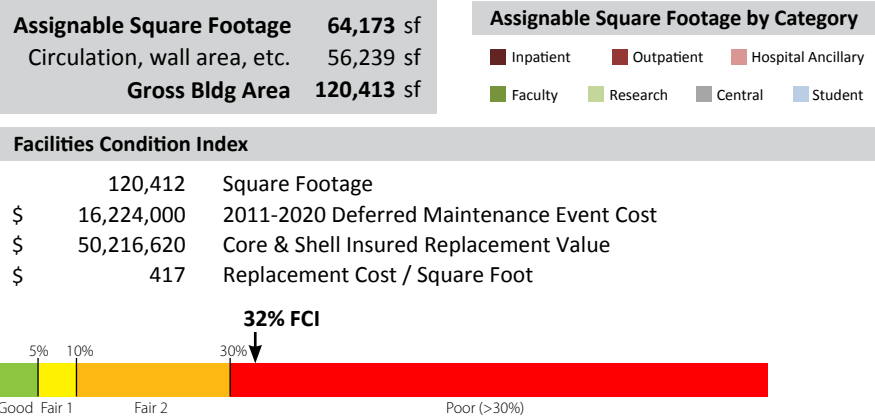
# Medical Research Building (MRB)

Built in 1961 as the University’s first dedicated research building, the Medical Research Building contains 120,413 GSF on nine floors. MRB houses research laboratories and office space for a variety of departments including Behavioral Neuroscience, Biochemistry, Otolaryngology, Molecular Biology, and the Vollum Institute. MRB has a FCI rating of 32% and is considered to be in ‘Poor’ condition. The building will need moderate to extensive renovation.

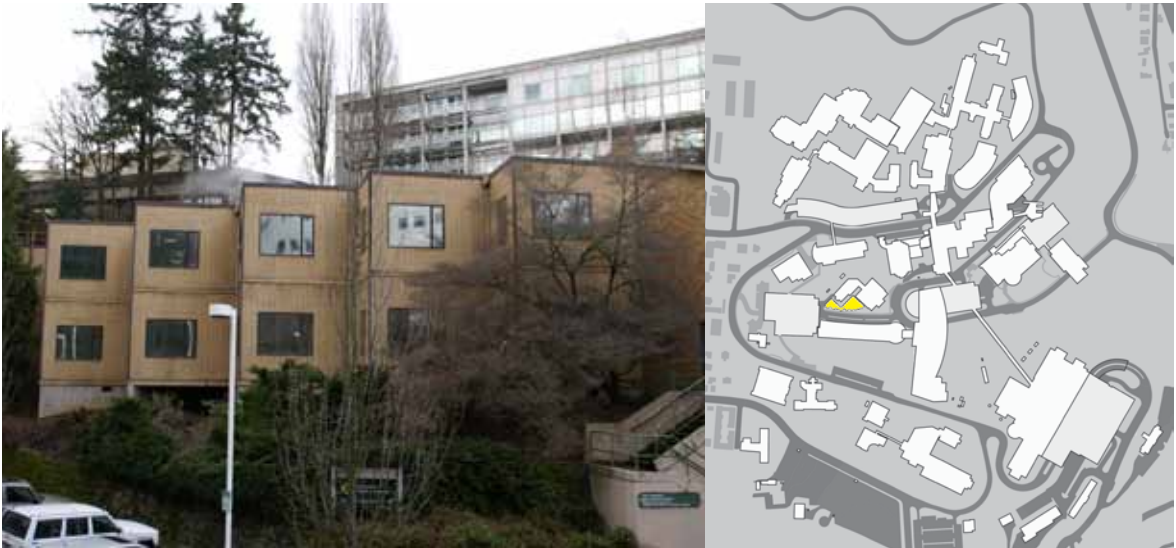
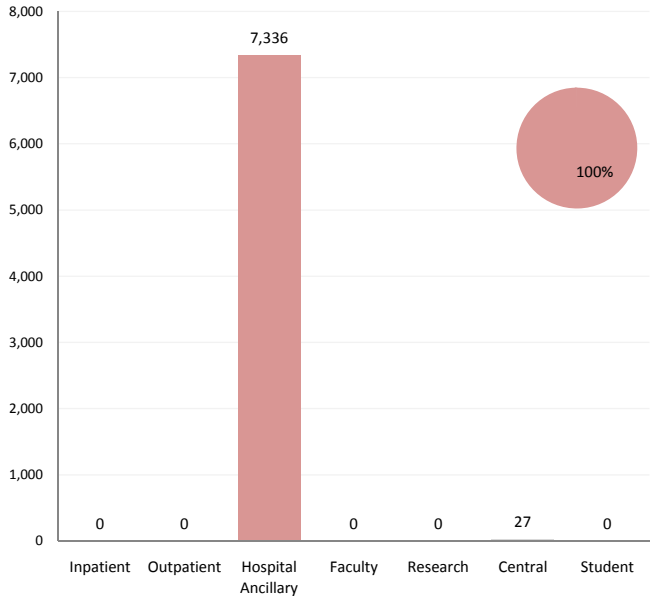
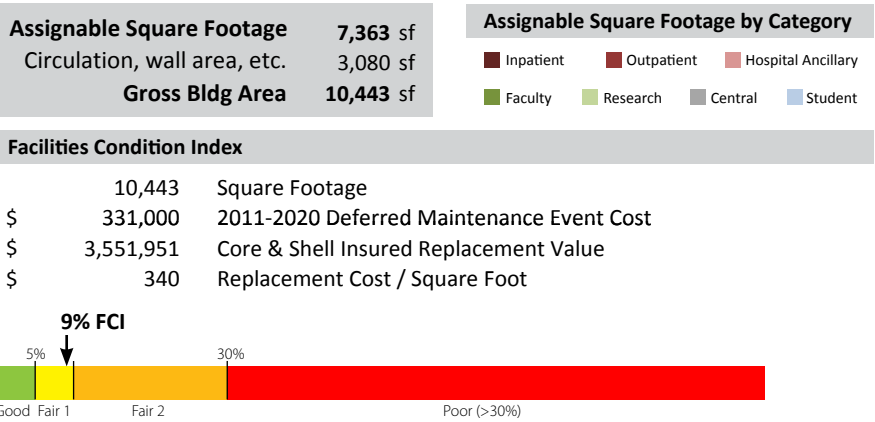
# Modular Building Structure (MBS)

Built in 1988 for staging construction, the Modular Building Structure contains 10,443 GSF on two floors. These temporary structures accommodate offices for the Hospital’s Medical Affairs, Business Development, and Managed Care. MBS has a FCI rating of approximately 9% and is considered to be in ‘Fair’ condition. These temporary structures occupy an important site and should be removed.
