### **3.** EXISTING FACILITY CONDITIONS

The focus of this chapter is on the Marquam Hill Campus where most of OHSU's buildings are located. The process of building condition assessment is discussed, and each building is rated to enable assessment of its future uses. In addition to the physical condition of a building, its historical significance and its location also play a part in deciding upon its future. Definitions of twenty-year facilities needs in the next chapter are used in conjunction with this assessment of building conditions to suggest logical scenarios for the use, adaptation or replacement of each building.

# Facilities Condition Assessment

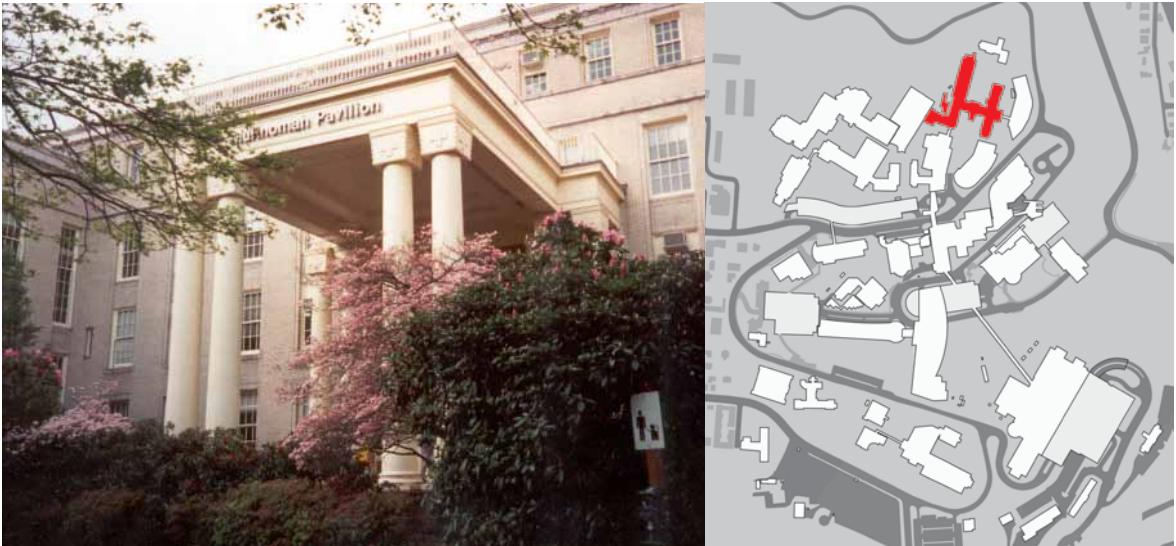
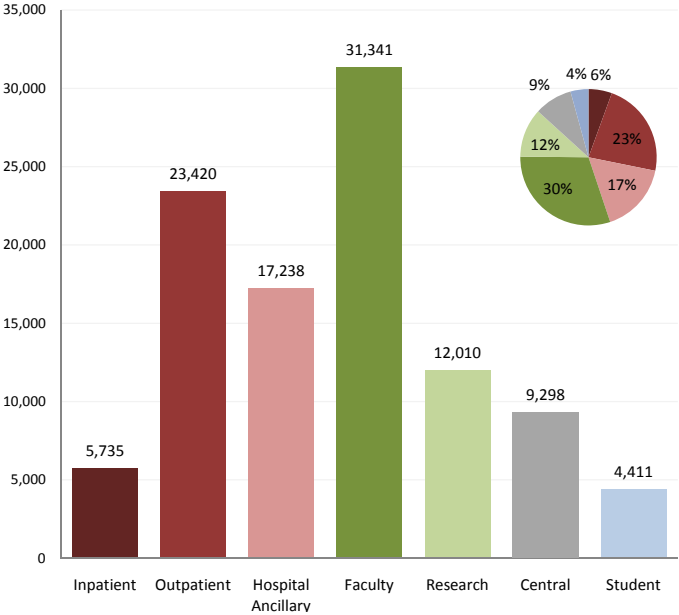
# Multnomah Pavilion (MNP)

Built in 1919 as the original hospital on Marquam Hill (aka the County Hospital), Multnomah Pavilion contains 210,910 GSF on seven floors. MNP now houses Inpatient Psychiatry, outpatient departments including Ambulatory Surgery and Adult Bone Marrow Transplant as well as offices for medical school faculty. MNP has a FCI rating of 35% and is considered to be in ‘Poor’ condition. Given its historic significance and size, full demolition of MNP is unlikely; moderate to extensive renovations will be necessary.

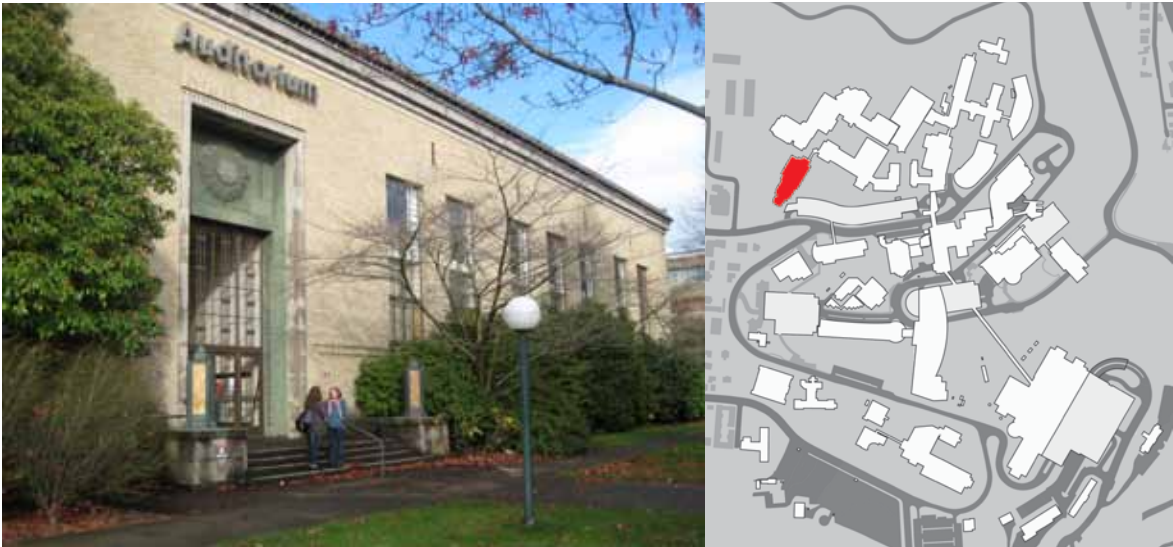
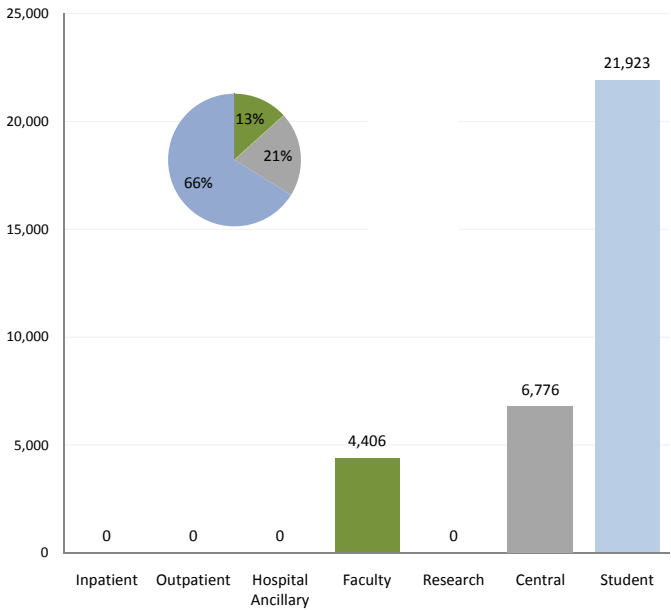
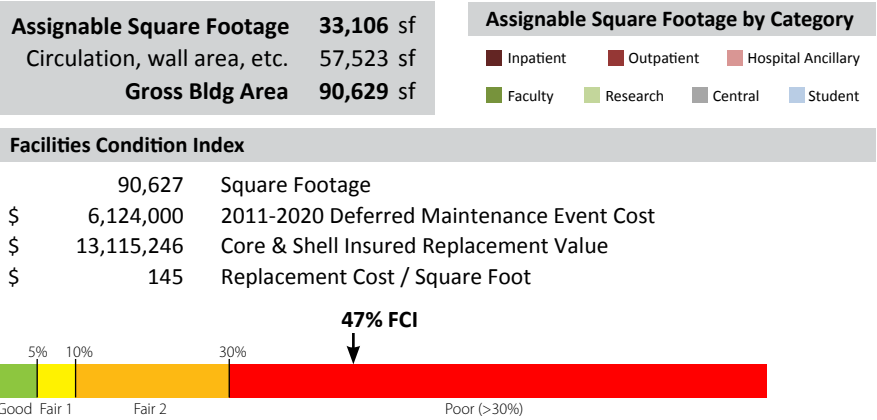
# OHSU Auditorium (AUD)

Built in 1939 as the University’s original library, OHSU Auditorium contains 90,629 GSF on four floors. AUD continues to house library stacks, the main auditorium on campus, and student assembly rooms. Receiving Dock 4 was added to the south side of the building but is functionally inadequate and needs to be relocated. AUD has a FCI rating of 47%, which is the second worst rated university building. Given AUD’s historic significance, demolition is unlikely; extensive renovation will be necessary.

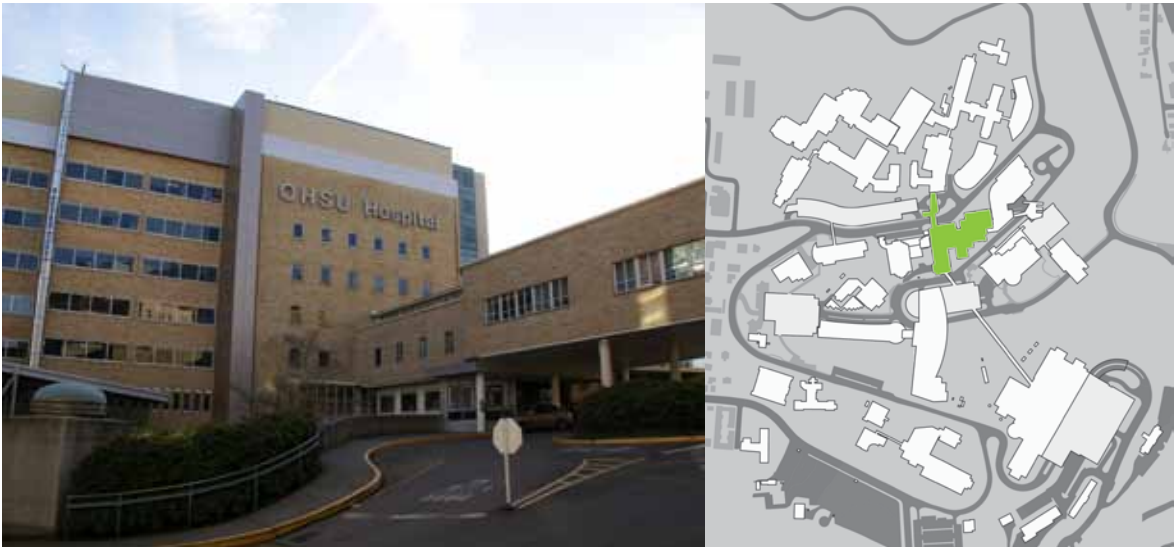
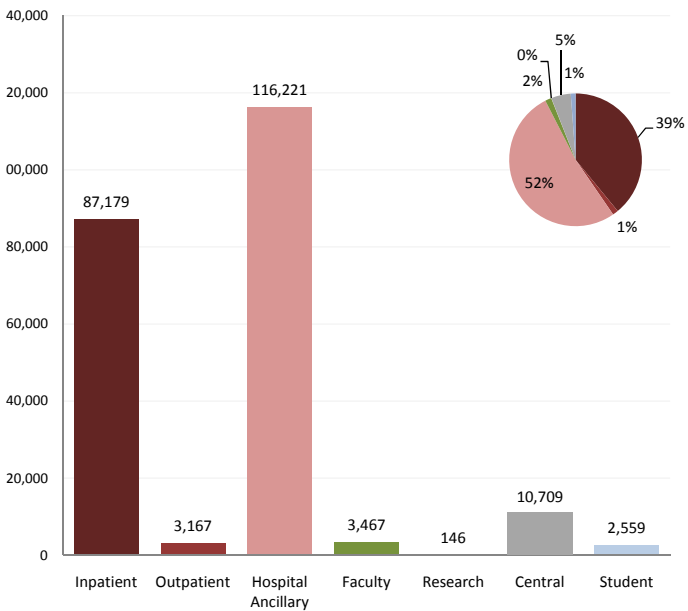
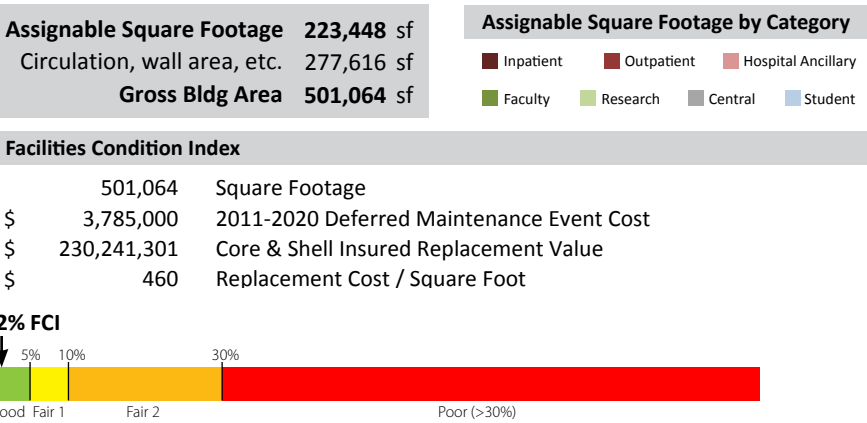
# OHSU Hospital (OHS)

Built in 1956, OHSU Hospital contains 501,064 GSF on fifteen floors. OHS houses Inpatient Services as well as Surgery and Intensive Care. The building has a FCI rating of 2% and is considered to be in 'Good' condition. Extensive recent upgrades have prolonged the expected life of OHS for another 50 years.

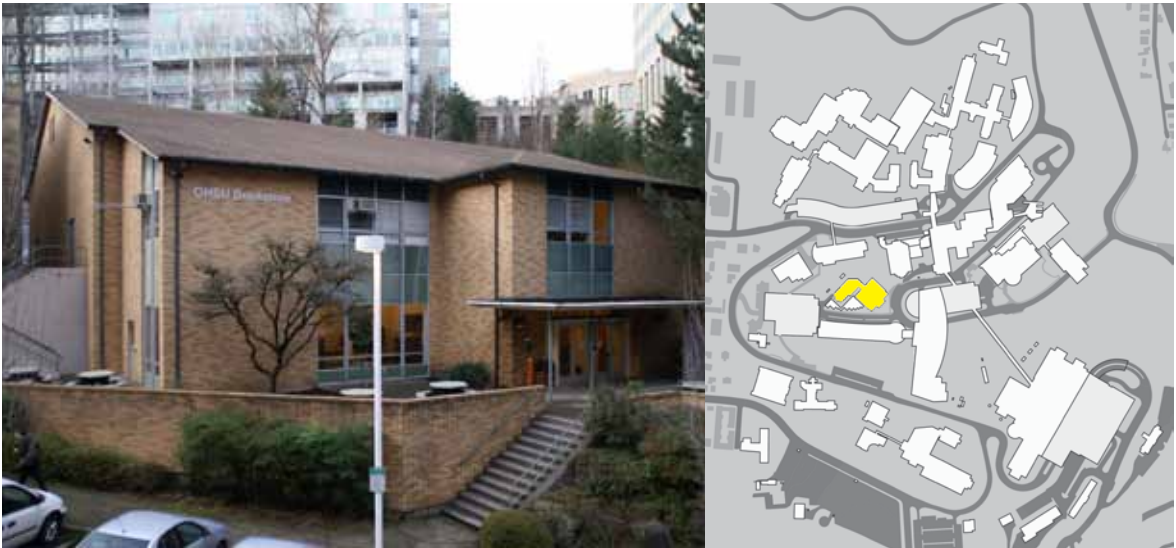
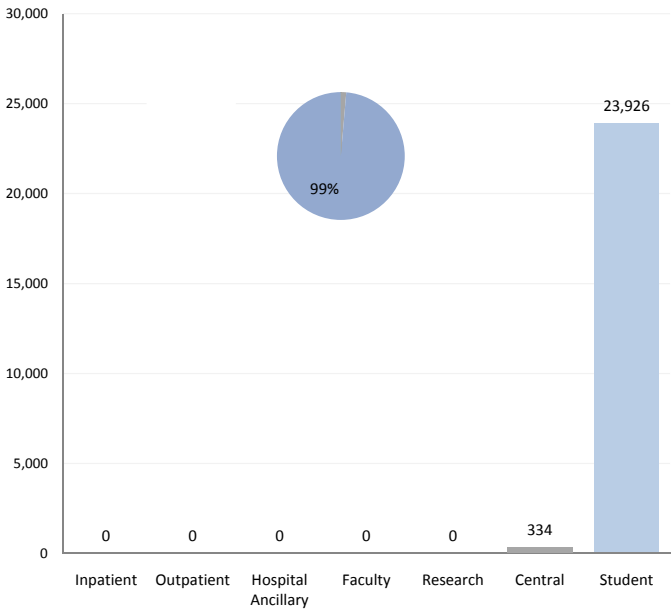
# OHSU Student Center (OSC)

Built in 1959 and expanded in 1990, the OHSU Student Center contains 33,634 GSF on two floors. OSC houses the student bookstore, pool and gymnasium. As teaching facilities are removed to the Schnitzer Campus, OSC functions may also move there incrementally. This building is in 'Fair' condition and does not need to be demolished unless the site is needed for other uses.

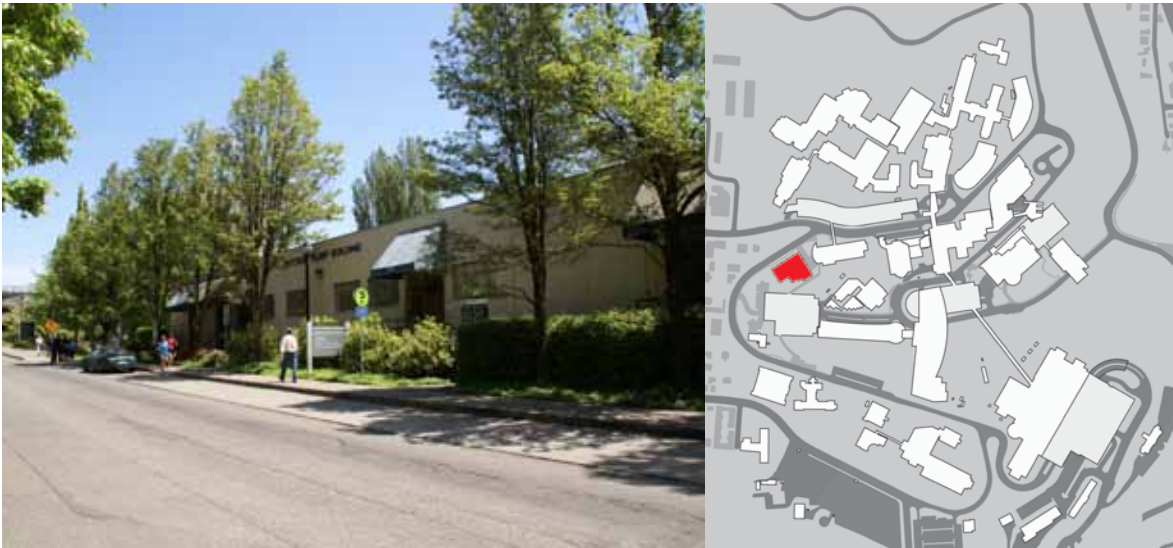
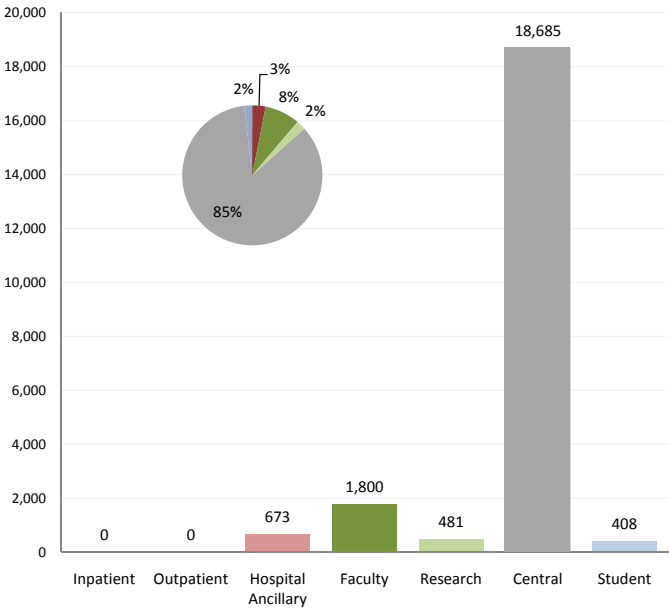
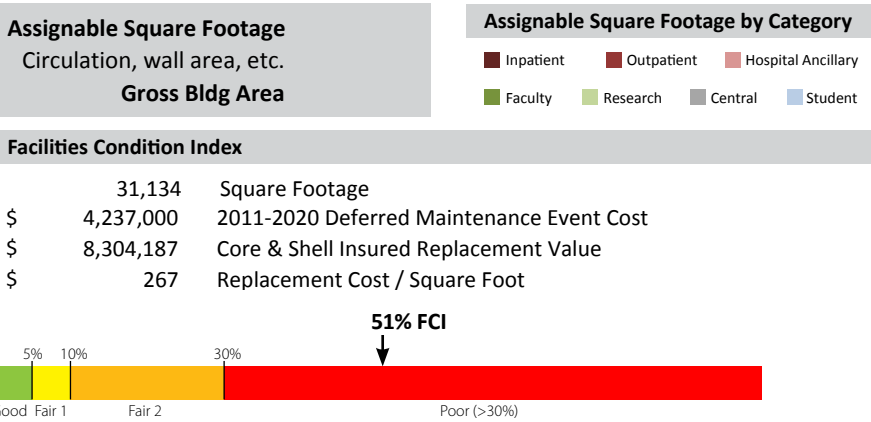
# Physical Plant (PP)

The Physical Plant Building contains 31,134 gsf over two floors. Physical Plant primarily houses offices for the Facilities department. PP has a FCI rating of approximately 51% and is considered to be in poor condition. This building could be demolished and its office backfilled into other buildings.

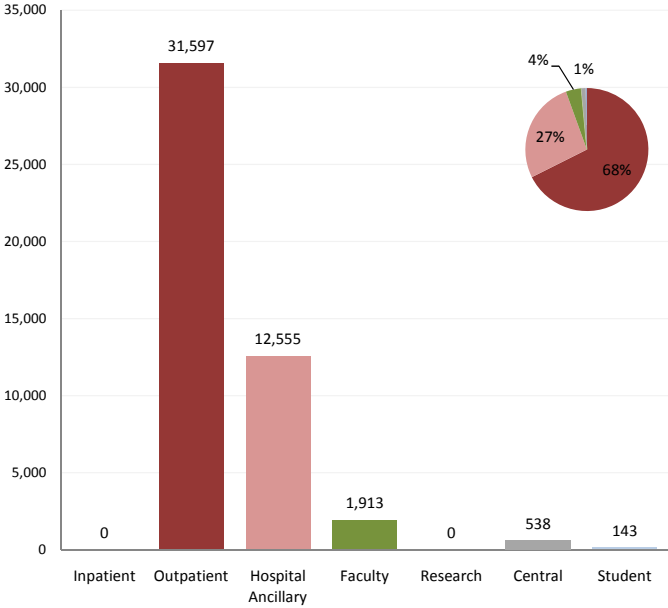
# Physician's Pavilion (PPV)

Built in 1992, Physicians Pavilion contains 84,635 GSF on four floors. PPV houses Outpatient facilities and clinics for a variety of departments including Internal Medicine, Surgery, Ear Nose & Throat, and Perinatal Care. Due to PPV being a leased building, it does not have an FCI rating but is considered to be in good condition.

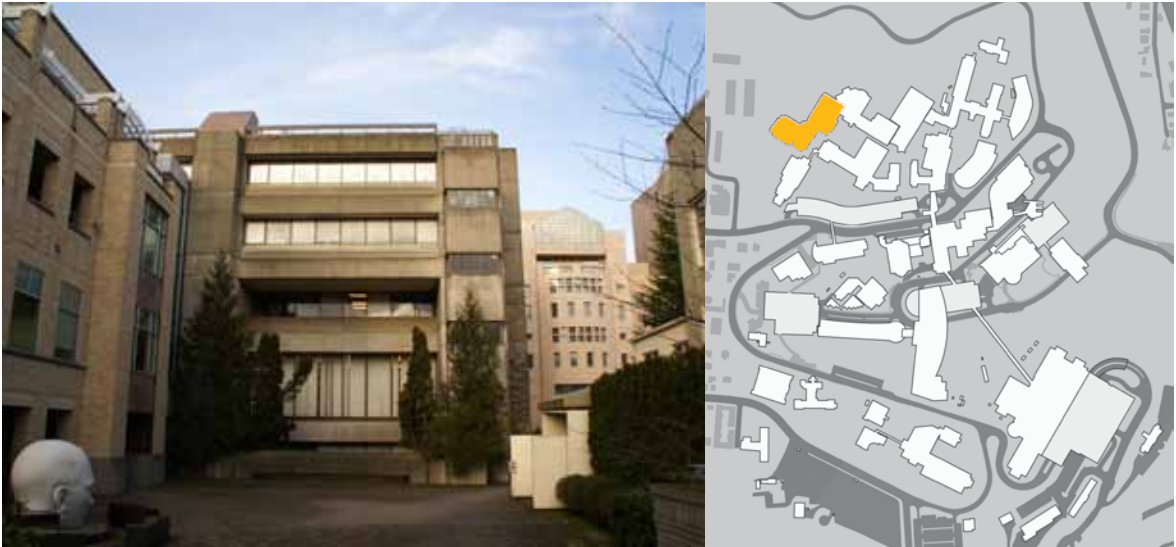
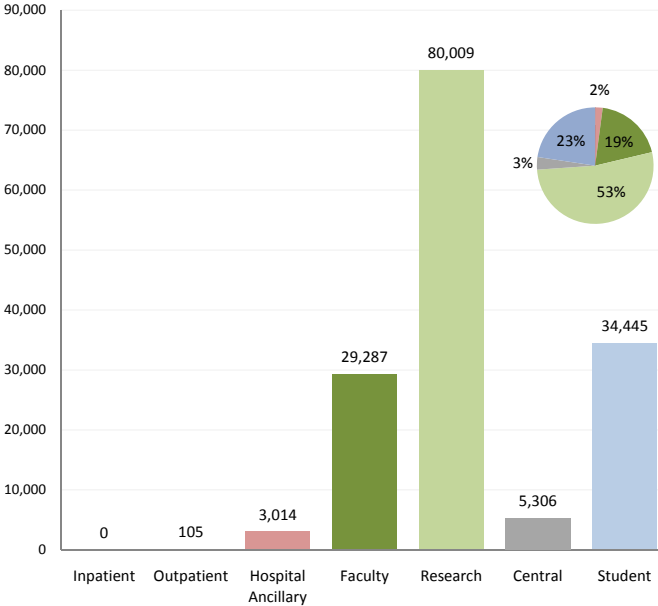
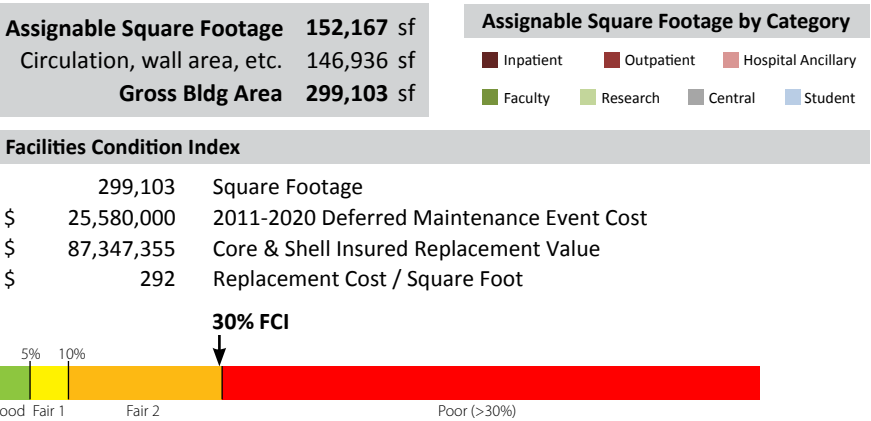
# Richard Jones Hall for Basic Medical Sciences (RJH)

Built in 1967 and later expanded in 1992, Richard Jones Hall contains 299,103 GSF on eight floors. It is essentially two buildings joined as one, the original Basic Science Building and the Basic Science Addition/CROET which opened 20 years later. RJH primarily houses research laboratory space for a variety of departments including the Center for Research on Occupational and Environmental Toxicology (CROET), Anatomic Pathology, and Biochemistry and Molecular Biology. RJH has a FCI rating of approximately 30% and is considered in fair condition; moderate renovations will be necessary.

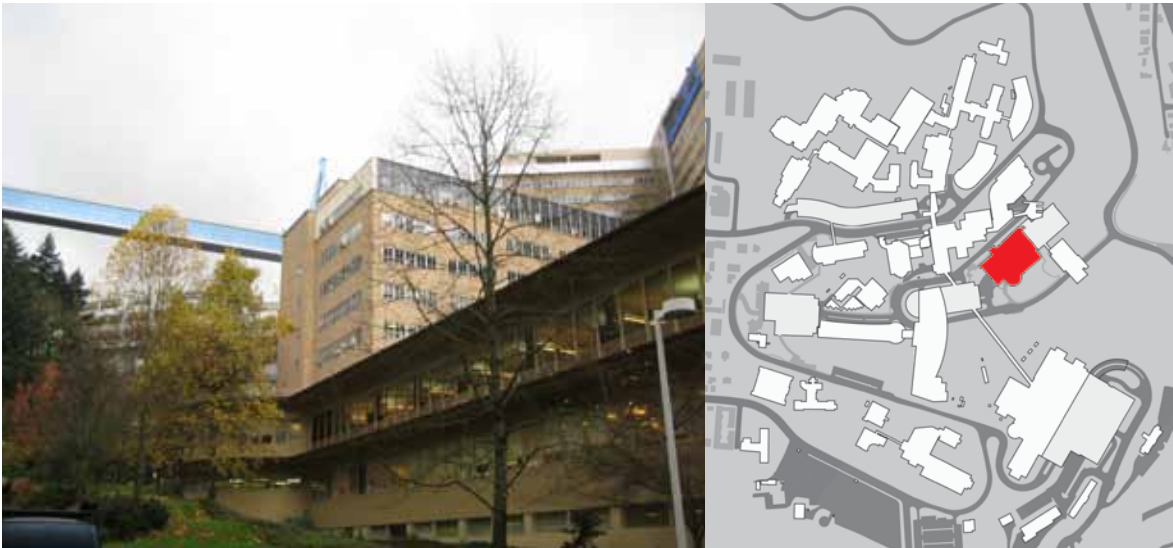
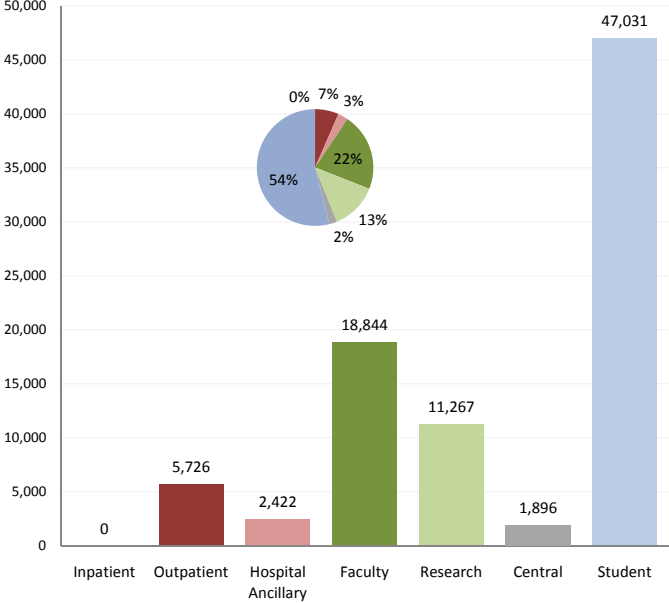
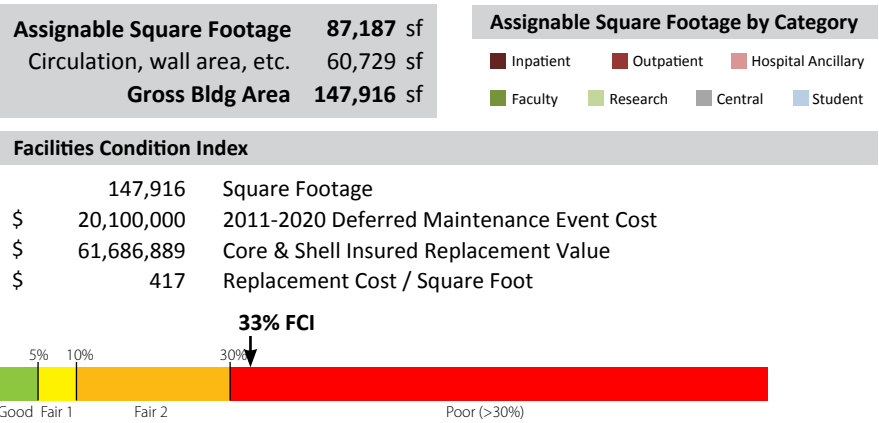
# School of Dentistry (SOD)

Built in 1954, the School of Dentistry contains 147,916 GSF on nine floors. SOD houses the School of Dentistry classrooms, laboratories, and faculty offices as well as the Outpatient Dental Clinic. The building has a FCI rating of 33% and is considered to be in ‘Poor’ condition. This building is a candidate for demolition.

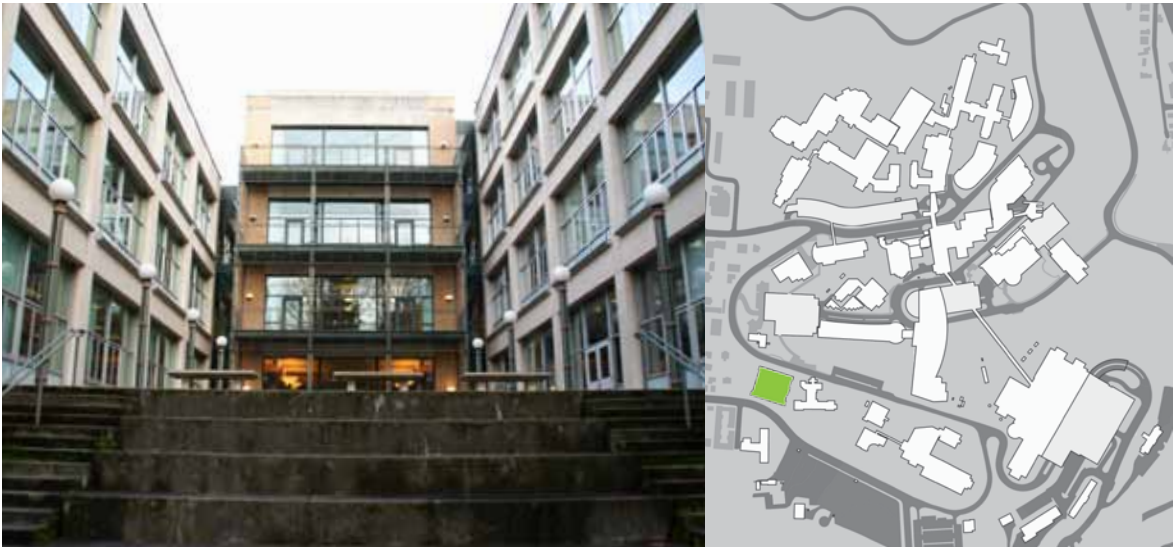
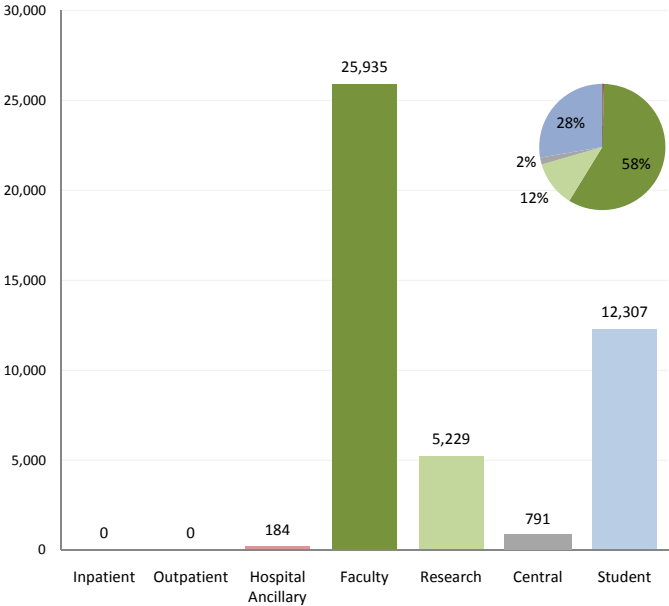
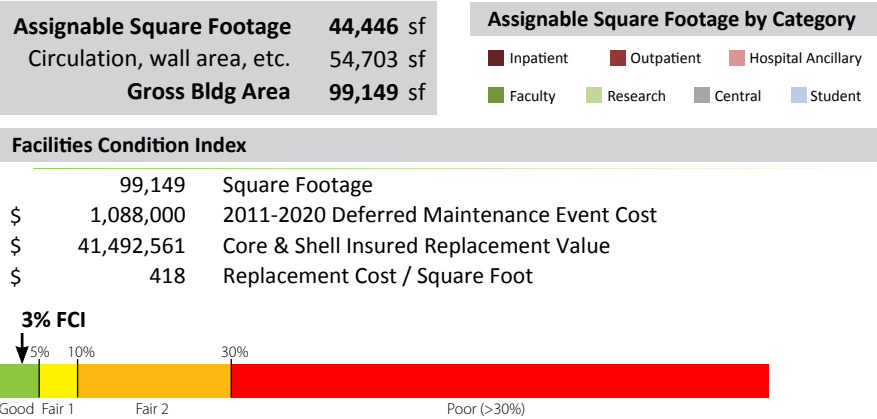
# School of Nursing (SON)

Built in 1991, the School of Nursing contains 99,149 GSF on seven floors. SON houses the School of Nursing classrooms and faculty offices as well as the Center for Evidence Based Policy. It has a FCI rating of 3% and is considered to be in ‘Good’ condition.

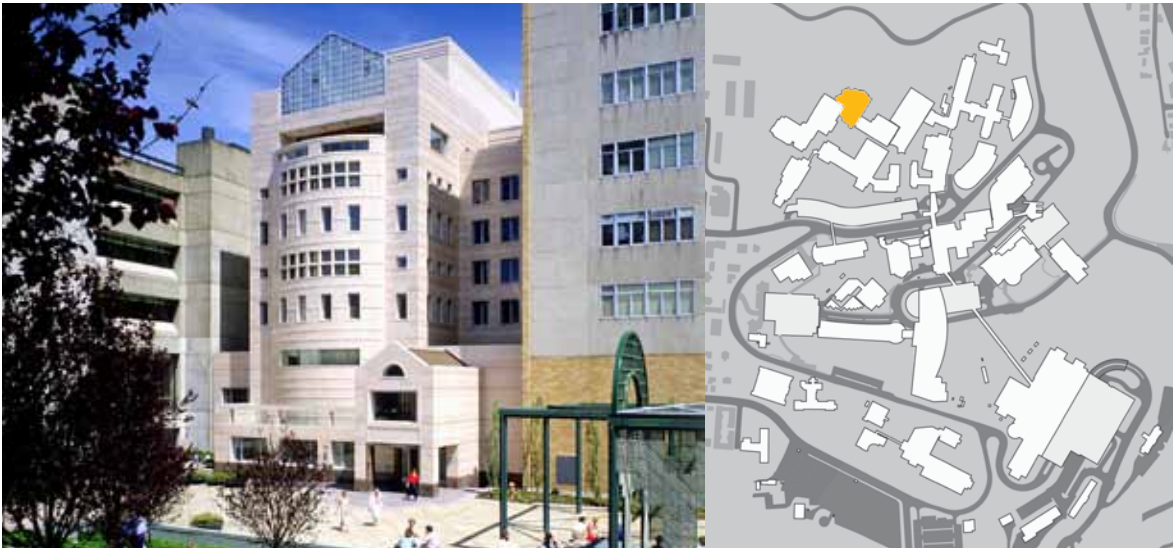
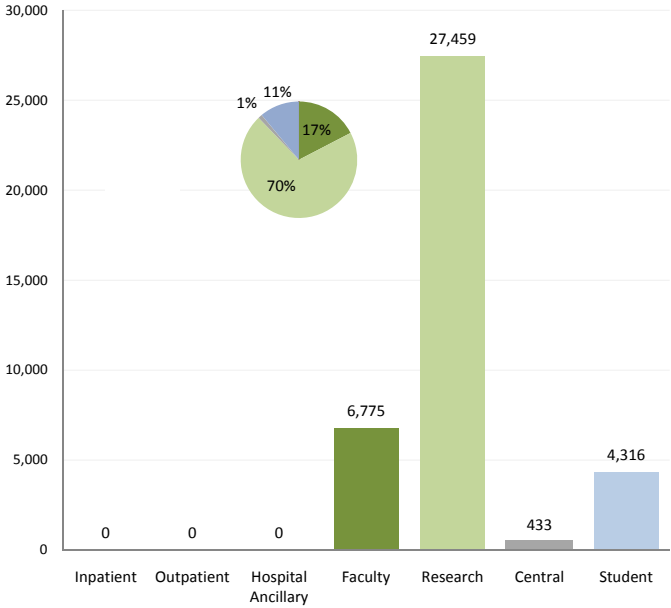
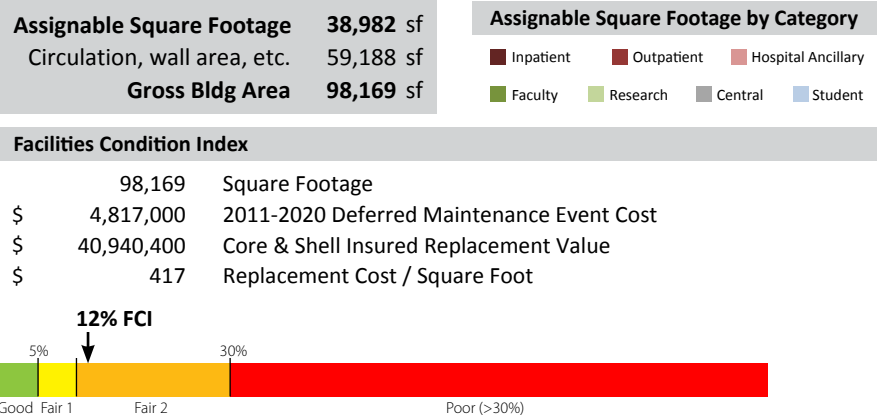
# Vollum Institute (VIABR)

Built in 1986, the Vollum Institute contains 98,169 GSF on six floors. VIABR houses research laboratories, support spaces, and offices for the Vollum Institute. The building has a FCI rating of 12% and is considered to be in 'Fair' condition, indicating that some renovation will be necessary.
