# Fatality Investigation Report

OR 2004-23-1

## Ranch hand killed by bulldozer while logging

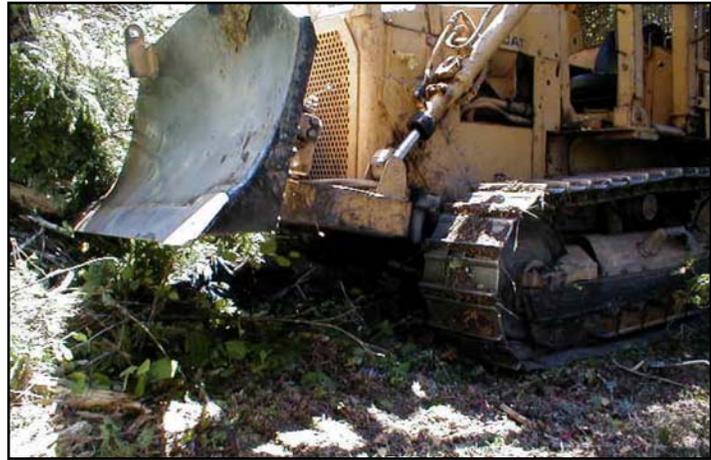
The final resting position of the bulldozer shows the front blade was raised about 1 ft off the ground when parked.

The sheriff's department conducted an inspection of the Caterpillar and determined the brakes were in good working condition. It was also noted that the Cat's brakes were set, the gear box was in reverse/neutral, and the bulldozer blade was raised 12-18 in. off of the ground. The tracks were setting on top of tree branches which appeared to have contributed to the Cat skidding or sliding backwards until it came to a rest against logs and a standing tree. It appeared the victim had been standing behind the cat, bent over, and looking away when the incident occurred.

**Recommendation #1. Before exiting a bulldozer, the machine operator must apply the brake and lower the front blade to the ground.**

According to employer and employee interviews the victim's work practice was to "Always lower the blade to the ground before exiting the operator's seat." This incident emphasizes that the rule allows no exceptions. Lowering the blade to the ground effectively stabilizes the machine from movement, more so if the blade is pushed down into a penetrable surface rather than simply floated to a resting point.
